Vernacular earthen buildings from Leiria, Portugal – Architectural survey towards their conservation and retrofitting

João Luís Parracha^{a,b}, José Lima^c, Maria Teresa Freire^{b,d}, Micael Ferreira^a, Paulina Faria^{a,b*}

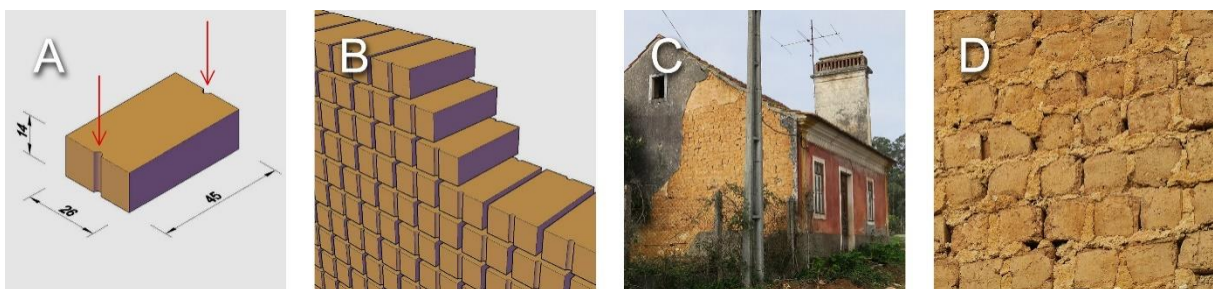
Figure 5. Leiria traditional adobe: A - schematic model of an adobe with side indentations; B - schematic model of an adobe masonry wall; C - inspected building 6 presenting adobe exterior walls; D – detail of a wall of the building mentioned in C

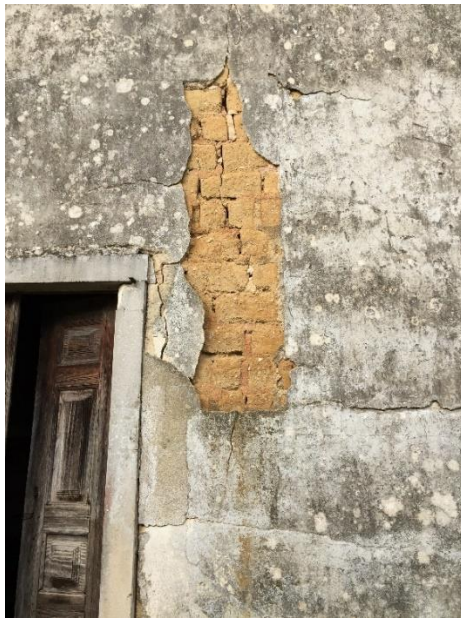
As shown in Figure 6, the most frequent anomalies are A1 (render/plaster decohesion), A2 (rising damp) and A4 (water infiltration from the roof), illustrated in Figures 7 and 8 and Table B.3 of Appendix B. The latter strongly increases in cases of abandoned dwellings.

Figure 7. Traditional dwelling repaired with cementitious-based render showing detachment after damaging the masonry surface (inspected building 17 – East facade)

- The repair or replacement of the air lime-based renders or plasters by cement-based ones should be avoided, to ensure that the walls keep drying the moisture that reaches them from the ground, or through migration from the indoor environment (Gomes et al., 2016; Gómez-Patrocinio et al., 2017). Whenever needed and possible, repairs on the walls should be performed with mortars based on the same earth originally used to build them (Gomes et al., 2018).

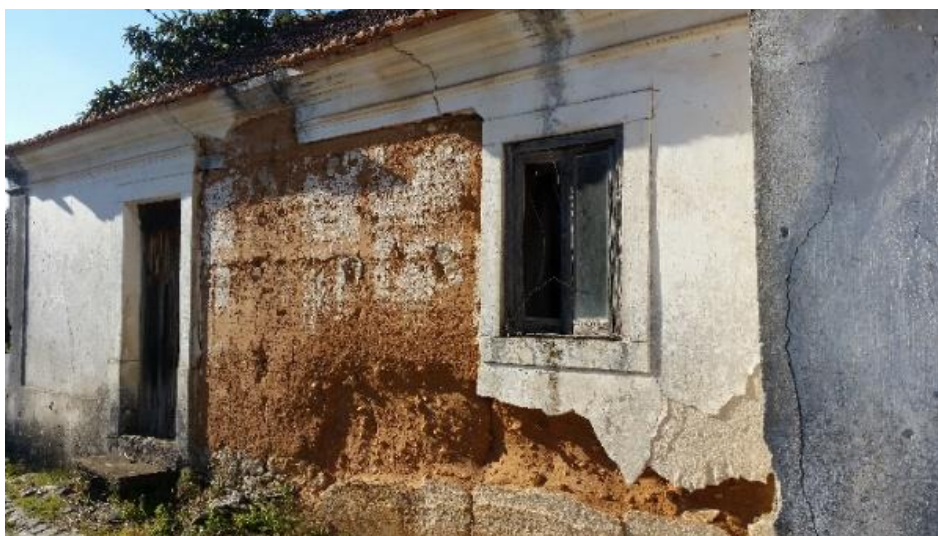
This type of degradation is frequently more severe at the base of the earth walls (basal erosion) (Figure 8). Being usually caused by the penetration of ground water by capillary action (McHenry, 1989) and transport of salts to the surface when it dries; sometimes it is also increased by rainwater splash after hitting the ground and by erosion caused by the wind. Furthermore, when the earthen walls moisture content is high (due to capillary rise, difficulties on drying, or lack of protective renders) their mechanical properties may drastically decrease. Therefore, basal erosion can cause significative loss of wall thickness, and loss of support under loading which can lead to overturning (Aytun, 1981).

Figure 8. Rammed earth with several basal erosion (inspected building 20)

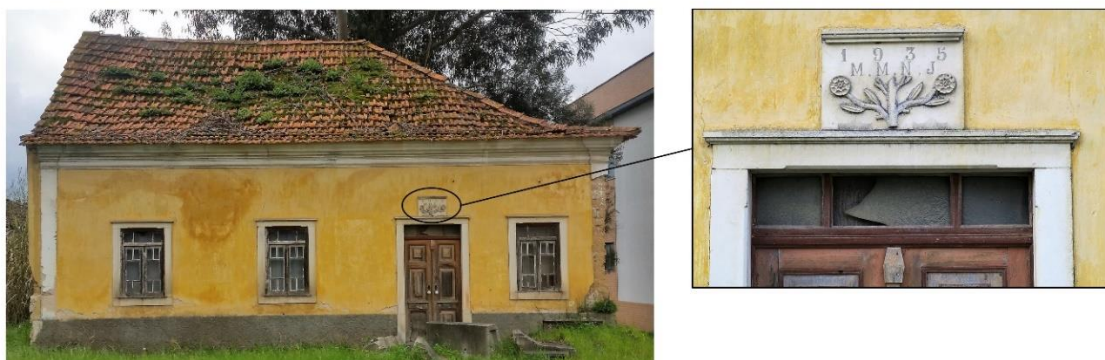
Inspected dwelling 4 (Figure 10) is located in a semi-rural area of the municipality of Leiria and was built with adobe masonry walls in 1935.

Figure 10. Semi-rural adobe dwelling from Leiria, Portugal (inspected building 4) with detail indicating the year of construction and the initials of the name of the owner

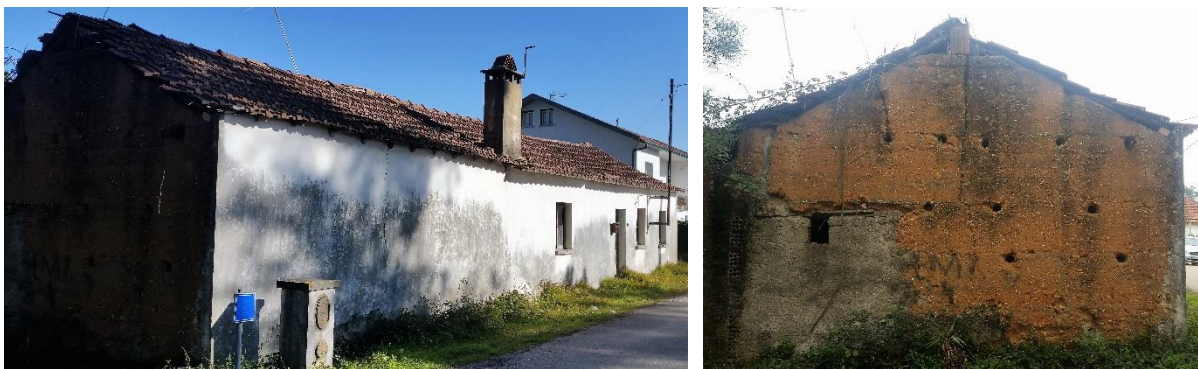
Inspected dwelling 29 (Figure 12) is located in the municipality of Pombal and was built with rammed earth walls in 1942. It is also located in a semi-rural area and presents a rectangular plan with dimensions of 10.85 m \times 3.25 m (Figure 13), with the main façade facing south. In the interior, the kitchen is positioned at west, the bedrooms are facing east, and the living room is in the center (Figure 13).

Figure 12. Rammed earth dwelling from Pombal, Portugal (inspected building 29)
