Repair Mortars for Rammed Earth Constructions

ABSTRACT

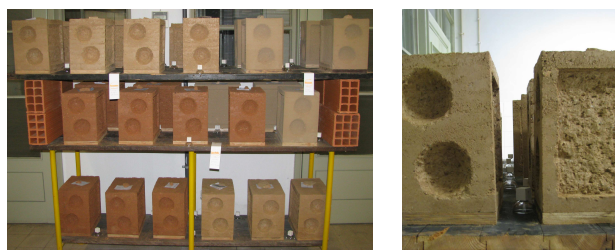
Two types of anomalies, most currently found in the exterior surfaces of rammed earth walls, were recreated on the sample blocks: superficial irregularity with loss of cohesion and deep voids (Fig. 2). The block samples are being kept in a controlled ambience - 20°C and 50% RH. The repair mortars will be applied over the two types of anomalies, in order to verify the compatibility between the substrate and the repair mortars and the applicability and effectiveness of the intervention.

Figure 2. Rammed earth laboratory blocks with different soils and with two types of surface degradation - deep voids and superficial irregularity with loss of cohesion.

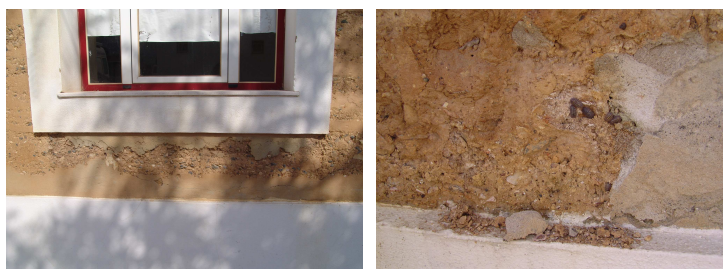
All earth-based mortars have a binding agent that can be only clay or added lime or cement. In the twentieth-century most of the references on conservation of earth construction, in order to improve the waterproofing properties of renders, recommended the addition of Portland cement. However some other studies refer that this component is not recommended for the repairs [Ashurst & Ashurst 1995], which may be a problem and represents a colossal mistake when used in unstabilised earth constructions [HB 195 2001, Guelberth & Chiras 2008]. Cement wicks moisture into the interior of walls causing deterioration. Also Delgado & Guerreiro [2006] do not agree with the use of cement-rich renders to cover unstabilised walls. Figure 3 shows an unrendered rammed earth house with a cement mortar in a localized repair; it is possible to see biological agents of degradation underneath the repair.

Figure 3. Rammed earth market house in S. Luís, Odemira. Left, repair with hard cement; and right, agents of degradation namely insects underneath the repair.
