Testing of a full-scale flat slab building for gravity and lateral loads

Full-scale testing of a two-storey flat slab structure is reported, undertaken in the SlabSTRESS research project; the construction and testing were planned and carried out at the ELSA laboratory of the European Commission's Joint Research Centre. The dimensions are three bays by two, spans 4.5 and 5 m, slab thickness 0.2 m, interstorey height 3.2 m. Two different longitudinal reinforcement details were considered; welded studs shear reinforcement was provided only in the second floor slab. The testing program included seismic tests for service and ultimate actions, using the pseudodynamic technique with virtual walls. To this aim a building structure was designed with primary walls and the flat slab frame as secondary element. Cyclic loading tests followed up to ultimate drift capacity of the structure. The sequence of tests included strengthening of a set of damaged connections using bolted bars in holes drilled through the slab, followed by cyclic testing to failure. The instrumentation was provided for the global response and the connections with local rotations in the columns and slab; cracking around th

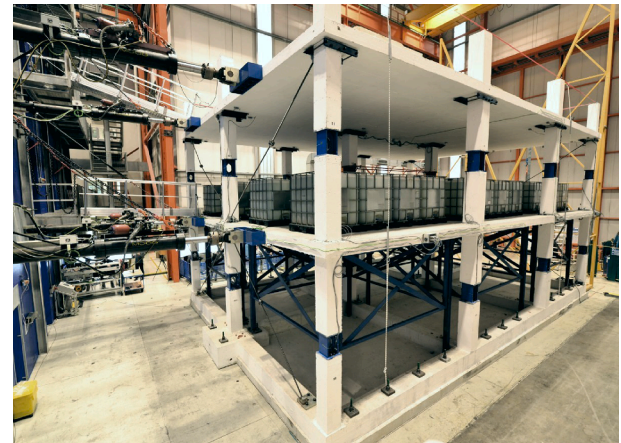
Fig. 11. Mock-up setup prior to the tests (North East view).

The experimental set-up is completed with some passive safety measures, designed to avoid catastrophic failures caused by unforeseen events during the tests. These measures included safety bracing along the A and D alignments (West and East side); fall protection systems, i.e. props on the lower floor and metal capitals on the upper floor. All these systems were designed to be activated only in case of emergency, while they did not alter the structural behaviour of the mock-up under normal conditions, see Fig. 11.

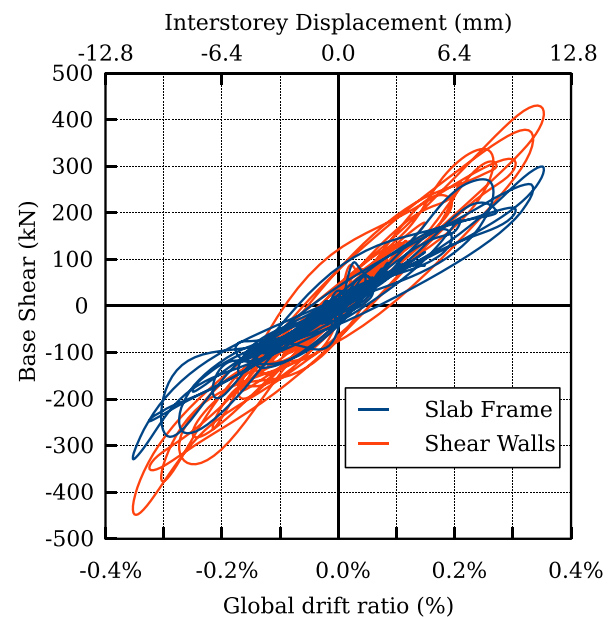
(a) Test SEIS-ULS, lateral displacements.

(b) Test SEIS-ULS, base shear force versus drift ratio.

Fig. 13. Global building response during the test SEIS-ULS.

The storeys lateral displacements for test SEIS-ULS are reported in Fig. 13a, while the seismic response in terms of the resultant of restoring forces (shear force at the base) versus drift ratio (displacement of top floor/ total height) is reported in Fig. 13b. The design values of interstorey drift for this test were 0.25% at the first storey (Level 1) and 0.42% at the second (Level 2). The recorded values from the test were 0.34% for Level 1 and 0.36% for Level 2. The almost equal interstorey drift ratio at the two levels reflect the frame-wall interaction, absent in the design values since they were computed according to the Eurocode 8

[14] specifications considering the seismic primary members only (the walls), with a factored stiffness (50% of the gross section stiffness) as suggested by the code. As Fig. 13b points out, the flat slab frame part showed a stiffness comparable to that of the walls, the average stiffness is 14514 kN/m for the flat slab frame part and 21186 kN/m for the walls, with the slab providing about 40% of total stiffness. Since in Test SEIS-SLS the stiffness of the flat slab frame was 21977 kN/m, the stiffness for test SEIS-ULS is about 66% with respect to that of test SEIS-SLS. This reduction is consistent with the initial slab cracking for an elastic model of the flat slab frame with no stiffness reduction for the column and a 50% reduction for the slabs gave a numerical value of 15416 kN/m, compared to the experimental value of 14514 kN/m reported above. In spite of the larger values of displacements attained in the second test, an essentially linear behaviour can still be assumed. The hysteretic damping in the cycle with maximum amplitude (time 7.548 s) lead to a damping factor value of 2.43%, with respect o the critical one.

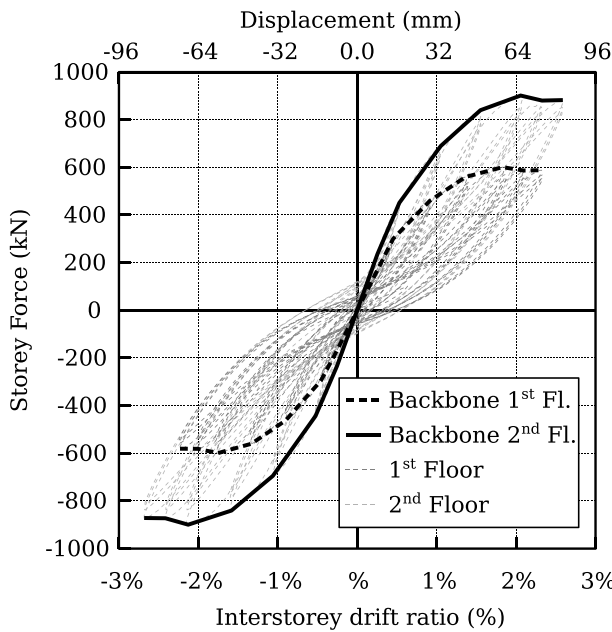
(a) Base shear vs global drift ratio.

(b) Storey forces as a function of inter-storey drift ratio.

Fig. 14. Global building response during the test CYC-1.

The global response is shown in Fig. 14a, in terms of total base shear, as the sum of all actuator forces, and the drift ratio of the second floor (top displacement divided by the total height of the building: 6300 mm), following the pattern in Fig. 7. Fig. 14b shows the relation of the sum of the two actuator forces at each storey to the interstorey drift ratio at each floor. The ratio of the actuator forces at the second and first storey was 2:1 and the displacement was controlled at the second floor. The first floor shows an increasingly higher interstorey drift ratio than the second floor. The maximum base shear is reached at 2% drift ratio. Beyond this level the 2.25% and 2.5% drift ratios were reached for nearly constant load. The first cycle for every drift ratio increase beyond 2% showed a very limited strength reduction. During the three cycles at each drift ratio level the strength deterioration was limited as well.

ratio. Starting from 2% drift ratio, the cycles were characterized by lower unbalanced moment on the first cycle and more significant strength and stiffness deterioration than the cycles at the previous drift ratio levels. The global response (Fig. 14a) was not affected by this local strength deterioration.

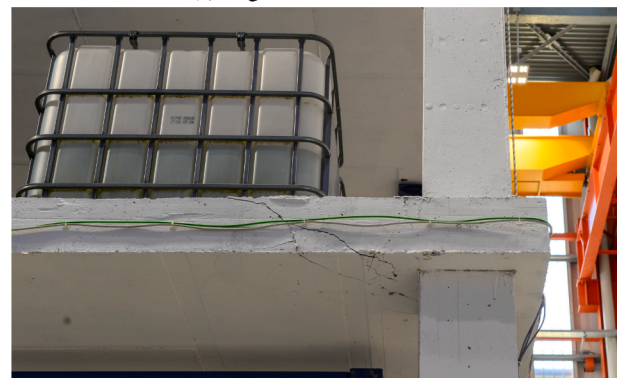
(a) Edge connections D2-1

(b) Corner connections D1-1 (short side)

Fig. 16. Edge and corner connections cracking at 2% drift ratio.

first floor along lines A and D orthogonal to the loading direction (Fig. 16). The most relevant cracks in the connections appeared on the vertical surface at the side of the slab. At 1.5% drift ratio a crack pattern of torsion and shear damage was clearly visible. The cracks opened wider at 2% drift ratio (Fig. 16) and and spalling of the concrete followed at 2.5% drift ratio (Fig. 17).

Observing the crack pattern, the failure mode is a combination of punching shear, with a cone reaching the top surface of the slab (Fig. 17) and torsion cracking in opposite diagonal directions on the side of the slab (Fig. 16). After the 2.5% test (Fig. 18) some portions of the spalled concrete around the connections were removed by hand, to avoid the falling of debris during the post-test measurement operations and the preparation of the following test. The failure cracks have an inclination of about 45° in agreement with the failure surfaces observed in slabs with similar amount of flexural reinforcement (whereas slopes of about 30° are more typical for slabs with significantly higher reinforcement ratios, see for instance [19], where slabs with different reinforcements in both reinforcements clearly show this effect).

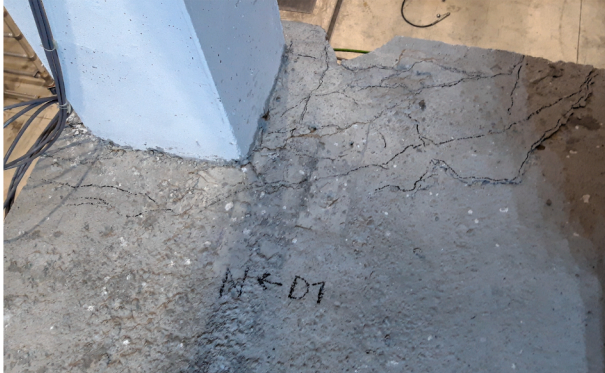
(a) Edge connections D2-1, top view

(b) Corner connections D1-1 top view

Fig. 17. Edge and corner connections cracking at 2.5% drift ratio.

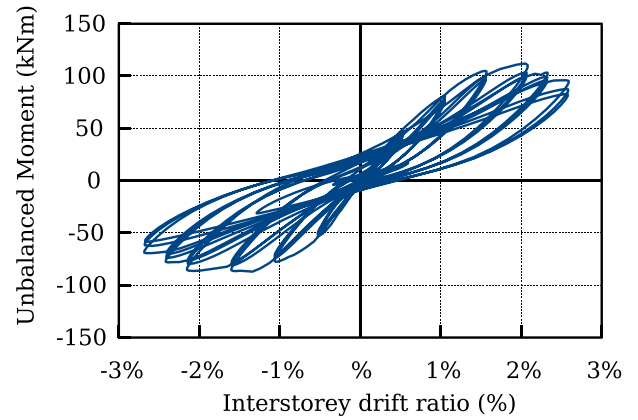
(a) Edge connection D2-1

(b) Corner connection D1-1

Fig. 19. First floor, edge and corner connections diagrams of unbalanced moment and inter-storey drift ratio: D2-1 (a) and D1-1 (b).

The instrumentation provided the moment and shear in the columns; the unbalanced moment is calculated summing moments at the ends of columns framing into a connection. The first floor edge connections on both sides A and D (see detail for connections D1-1 and D2-1 in Fig. 19a) reached the maximum unbalanced moment at $\pm 1.5\%$ interstorey drift

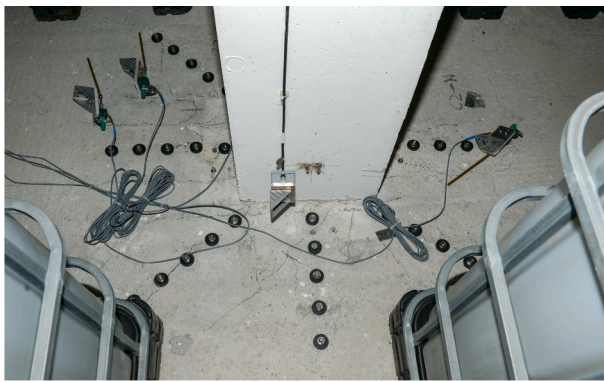
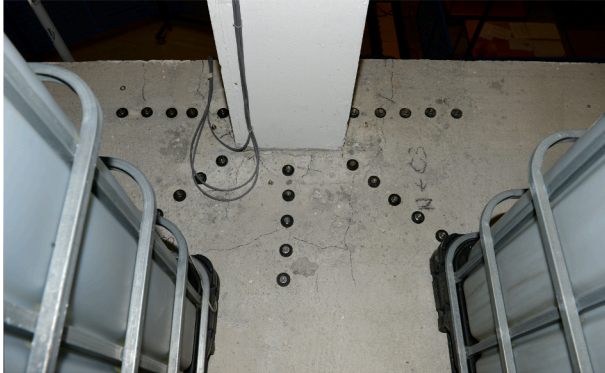
(a) Strengthened interior connection C2-1

(b) Strengthened edge connection C3-1

Fig. 21. Strengthened slab-column connection at first floor: interior C2-1 (a) and edge C3-1 (b).

repair could be carried out. Therefore some of the slab-column connections along lines B and C were strengthened improving the punching-shear resistance, before the cyclic test CYC-2. This operation represents a realistic scenario, in which retrofiting is carried out after a major seismic event. The partial retrofit allows a direct comparison among the response of unreinforced connections, and those with post-installed and pre-installed shear reinforcement. Post-installed bolts were used in three connections in positions B1-1, C2-1 and C3-1. Bolts were placed into drilled holes across the slab thickness, reproducing the layout of headed-studs cast into the second floor slab. Threaded bars (8.8 steel grade) with 10 mm diameter were used, with rigid circular washers with 40 mm external diameter and 10 mm thickness. Nuts on both sides enabled to pre-load each bolt, ensuring the efficiency of the fastening. Fig. 21a and Fig. 21b show the strengthening of the interior connection (C2-1) and an edge connection (C3-1), respectively.

The strengthening was designed before the mock-up manufacturing, therefore small plastic tubes (4 mm diameter) were placed into the concrete slab in all the connections before casting, to ensure the positioning and verticality of drilled holes, avoiding any interference with longitudinal rebars and measuring devices. Nevertheless, the applicability of this technique for ordinary applications remains valid, it is only slower to perform and less precise for positioning. A rebar scanner may correctly locate existing reinforcement bars making the application more effective. The tubes did not alter the cracking pattern: during the surveys performed after each test, the radial cracks of the slab resulted not affected by the pre-holes. Once test CYC-1 ended, water tanks were removed from the first floor, both for practical reasons related to the installation and to reproduce the removal of non-structural loads, as would have been done for an intervention on a real building. The slabs were drilled, following the pre-holes, and the bolts were installed and tightened with a torque wrench to apply a preload of 10 kN. Finally, the water tanks for the additional loading and measuring instruments were

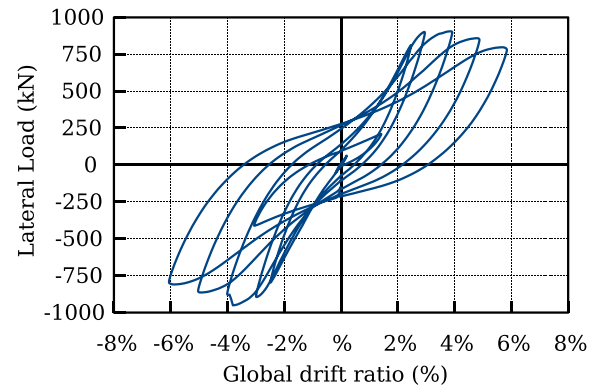
(a) Global lateral load – top floor drift ratio

(b) Unbalanced moment to interstorey drift ratio diagram for connection B2 in the first floor slab.

Fig. 22. Test CYC-2: (a) Global lateral load vs. top floor drift ratio; (b) Unbalanced moment vs. interstorey drift ratio diagram for connection B2-1.

The event that caused the onset of the global load reduction was the punching of connection B2-1 (Fig. 22a); after the two cycles at 2.5% and 3%, during the first cycle to -4% in the Westward direction the unbalanced moment dropped with a reduction of more than 50%; the response in the +4% half cycle showed significant strength deterioration as well; the cycles at 5% and 6% drift ratio show a post-peak response with low stiffness. The failure mode is evident observing the typical damage on the top slab surface around the column extending to a distance approximately up to 600 mm from the column face in all directions (Fig. 23a). The behaviour of the strengthened interior connection at C2-1 was significantly improved compared to the similar but not strengthened connection B2-1 (Fig. 24). The connection B2-1 degraded rapidly after punching, whereas the strengthened connection (C2-1) was able to survive to the end of the test, for nearly 6% storey drift ratio, without failure and limited damage showing on the slab surface (Fig. 23b). A similar performance was shown by the other two strengthened connections on the edges.

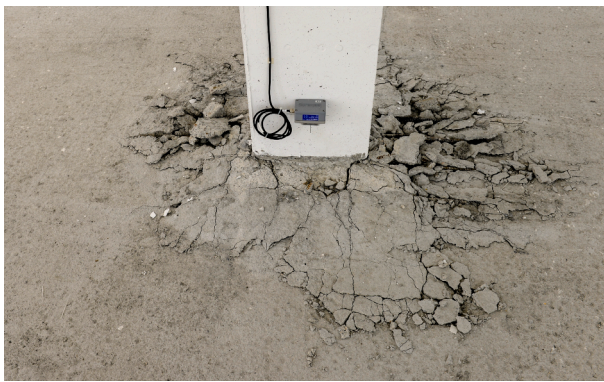
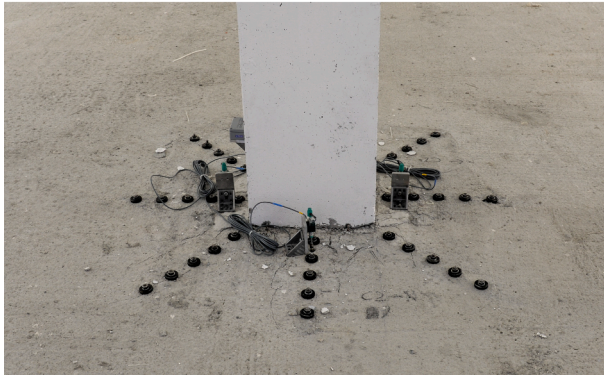
(a) As-built interior slab-column connection B2-1

(b) Strengthened interior slab-column connection C2-1

Fig. 23. As-built (a) and strengthened (b) interior slab-column connections at end of test CYC-2.

actuators was reached. A post-test examination showed also the breaking of the longitudinal reinforcement at the base of the column in position B2.

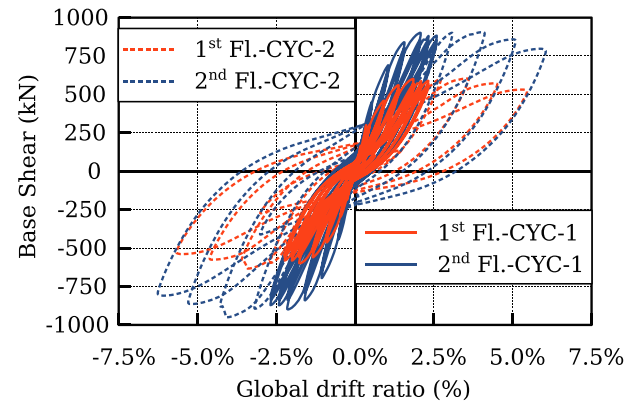
Fig. 26. Comparison of global response in tests CYC-1 and CYC-2, both at floor 1 and floor 2.

The global response in Fig. 25 and 26 confirms the capacity of flat slab frames to develop inelastic deformations with a stable response up to 2.5% drift ratio, for gravity shear ratios 0.2 and 0.3 in the interior connections. With part of the configuration changed in the second cyclic test CYC-2, still the results obtained provide insight on the continuation of the first test to higher drift ratios. Fig. 26 shows the response of the two cyclic tests in sequence. The repetition of the 2.5% global drift ratio cycle in test CYC-2 showed a response nearly identical to that of test CYC-1 at the same drift ratio. The interior connection B2-1 had GSR = 0.3 as in test CYC-1 and punched at 3.8% drift ratio. These results agree with the previous tests in the literature with similar gravity shear ratios, reaching ultimate drift ratios ranging between 2.5% and 6% [5].
