Licenciatura em Ciências de Engenharia Electrotécnica e de Computadores

# Rail Corrugation: A Software Tool for Detection and Analysis Using Wavelets

Dissertação para obtenção do Grau de Mestre em Engenharia Electrotécnica e de Computadores

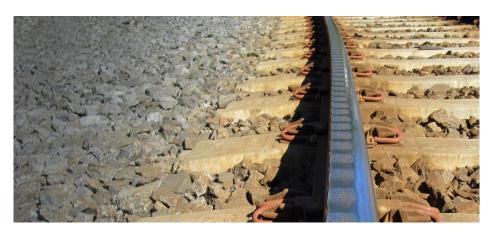
Rail corrugation (figure 1.1) displays wavelengths between 3cm and 100cm and it is divided in two groups: short wavelength rail corrugation (3cm to 10cm) and long wavelength rail corrugation (10cm to 100cm) [6].

Figure 1.1 – Example of a corrugated rail [2]

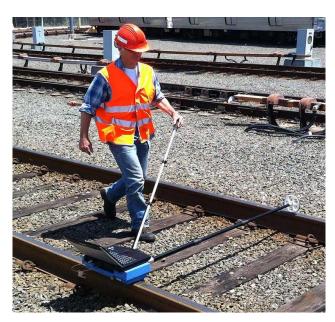
CAT (RailMeasurement Ltd) is an instrument that can be operated and carried by one person. It can only analyze one rail. While is analyzing the longitudinal profile of the surface of the rail it can also measure its acoustic roughness. For high speed rails this is not a very good method because it analyzes the rail at the speed of the person walking (approximately 1 m/s) [9], [10].

**Figure 1.2** – CAT being used to detect any signs of corrugation on the track [10]

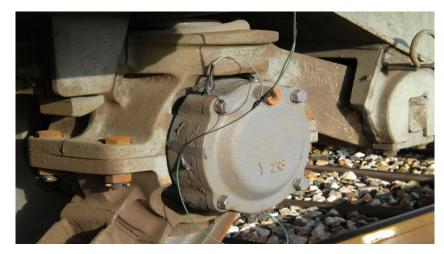
The HSRCA (RailMeasurement Ltd) is designed to measure the longitudinal irregularities in rails at line speeds (approximately 120 km/h). The main irregularities measured are corrugation and acoustic roughness. The hardware of the HSRCA is accelerometers on both axle boxes. This instrument can measure both rails at the same time [13].

Figure 1.5 – HSRCA being used to detect any signs of corrugation on the track [13]

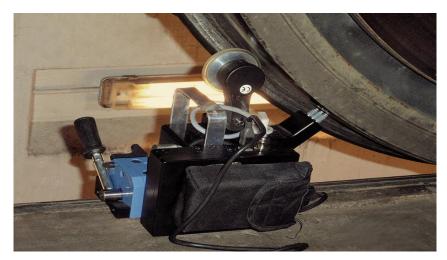
The Tritops can be carried by one person and it can measure 4 wheels at the same time [14].

Figure 1.6 – TriTops being used to detect any signs of corrugation on the track [14]

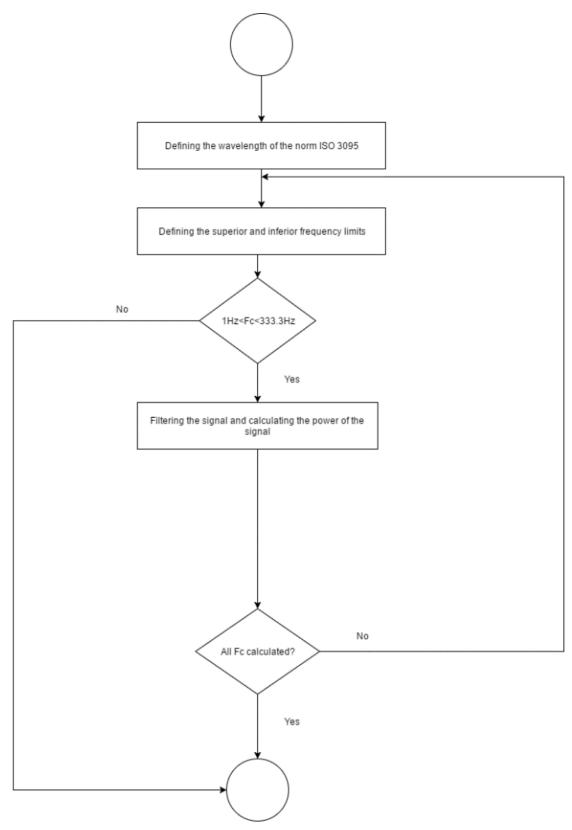
In figure 3.2 it is a flow chart explaining how the implementation was done.

Figure 3.2 – Flow chart of the implementation of the one third spectrum function
