IT'S WHAT'S INSIDE THAT COUNTS: AN ASSESSMENT METHOD TO MEASURE THE RESIDUAL STRENGTH OF ANOBIIDS INFESTED TIMBER USING MICRO-COMPUTED TOMOGRAPHY

João L. Parracha¹, Manuel F. C. Pereira², António Maurício², José S. Machado³, Paulina Faria⁴ and Lina Nunes⁵

Keywords: Timber, Anobiid infestation, Micro-computed tomography, Screw withdrawal, Damage assessment.

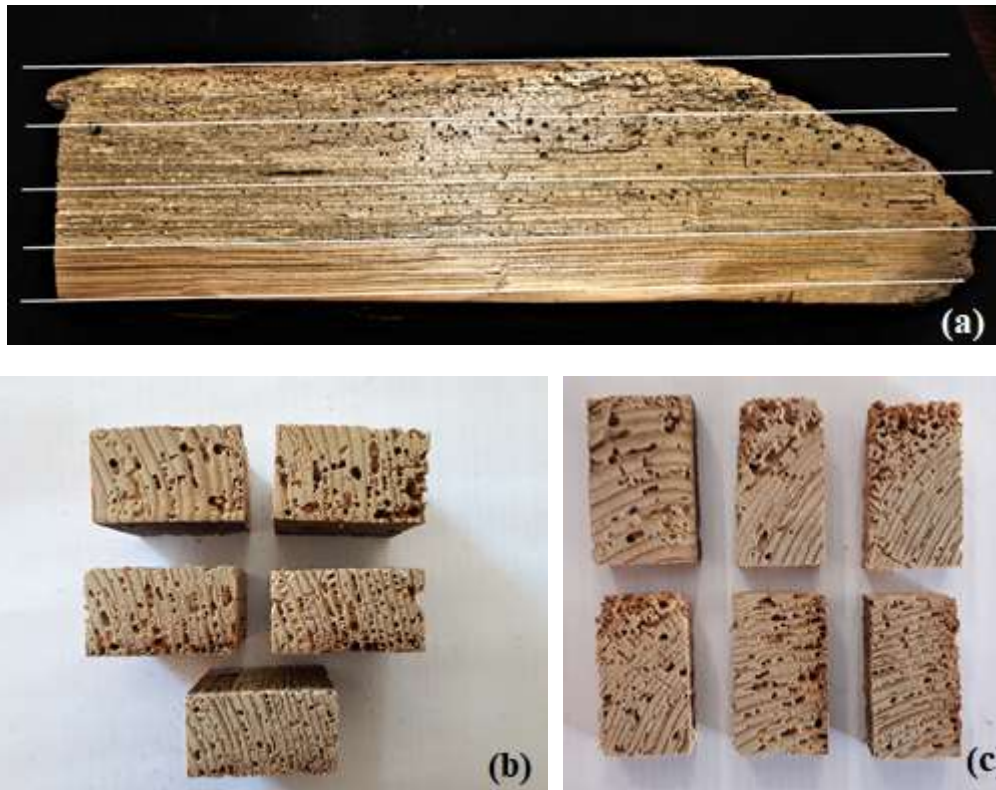
The beam was then divided in 4 segments (3 presenting degradation and the heartwood (Fig. 1a) and 17 samples of approximately $40 \times 20 \times 40 \text{ mm}^3$ were cut (Fig 1b). After that, and because these initial samples cannot be submitted to a procedure like micro-computed tomography due to their relatively large size, samples were cut again in order to obtain 17 “new” paired samples with approximately $40 \times 20 \times 10 \text{ mm}^3$ (Fig 1c) [4].

Figure 1: Sampling [4]: (a) timber beam initially divided in 4 segments; (b) some of the 17 samples resulting from the first cut of the beam and (c) some of the 17 “new” paired samples resulting from the second cutting process.

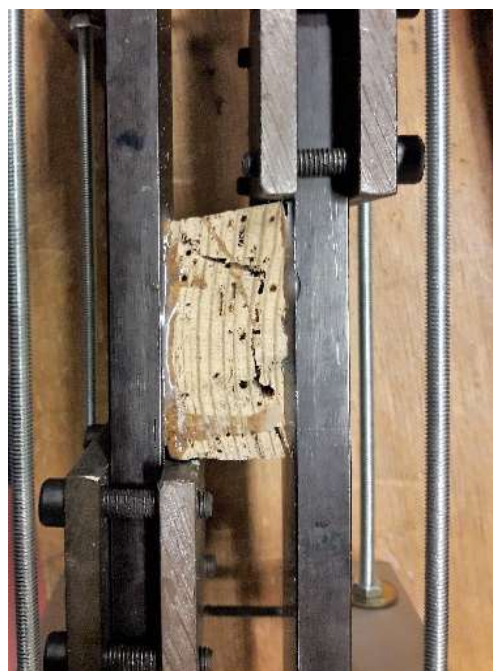
Figure 6: Rupture of the sample by shear parallel to grain test [4].
