Durability to marine environment of innovative products for consolidation and chromatic reintegration of historical renders

Keywords: Historical renders, consolidation, nanostructured products, chromatic reintegration, salt crystallization cycles

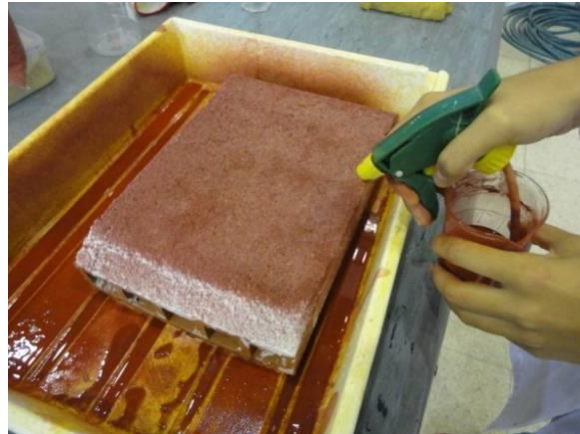
Consolidant products' application was carried out in a conditioned room, at $T=20\pm 2^{\circ}\text{C}$ and $50\pm 5\%$ RH, using a manual spraying technique at a distance of 20-30 cm [17]. Each consolidant product was nebulised with ten consecutive applications on the specimen's surface (Figure 1).

Figure 1. Application of consolidant product by nebulization on a mortar specimen.

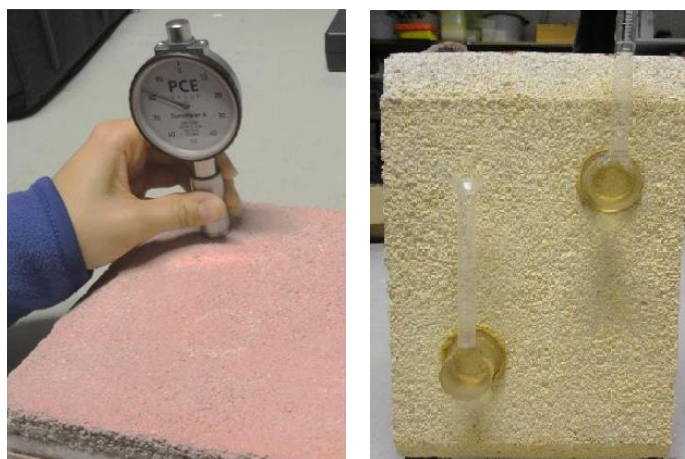
The mechanical strength was checked by the durometer hardness Shore A, PCE Group (ISO 7619:1997 and ASTM D 2240) [20, 21] and the water behaviour was checked by a water absorption test with Karsten pipes [22] (Figure 2).

Figure 2. Characterization of consolidant treatments: a) durometer (Shore A); b) Karsten pipes.

The surface hardness of mortars can be evaluated with a durometer, which measures the resistance to penetration of a pin pressed against the material under study. In this case a durometer Shore A was used, suitable for soft materials, and usually used for testing mortars.

Water absorption test at low pressure is used to verify possible water permeability variations in treated mortar, by comparison with the values of untreated mortar. Karsten pipes, that simulate wind dynamic pressure equivalent to about 140 km/h [24], are used. In each specimen two pipes were placed and fixed with mastic. The time required for total absorption of water (4 ml) into each Karsten pipe was measured.

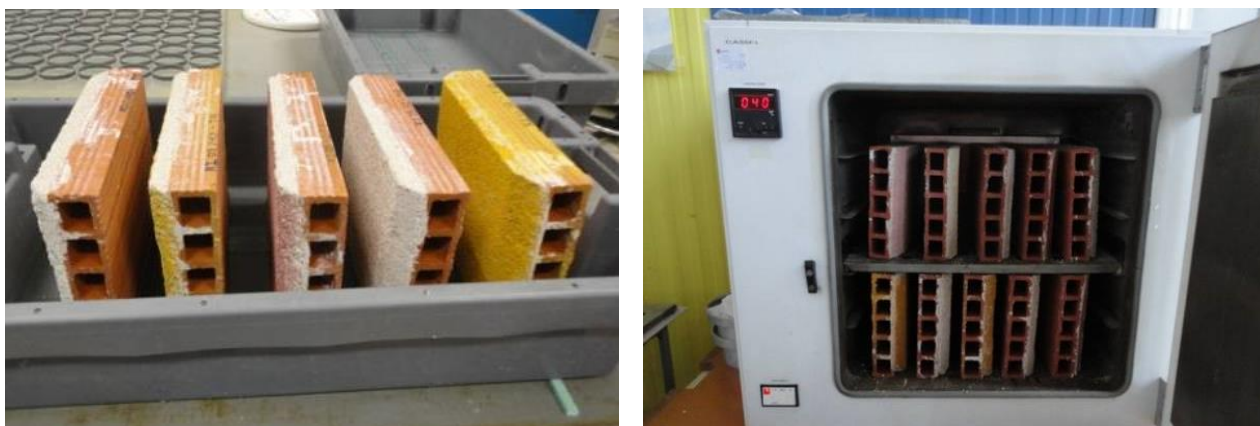
After consolidation treatment, five dissolution-crystallization cycles were carried out over a total period of 5 weeks (Figure 3). The samples were partially immersed in NaCl solution (27g/L – similar to sea content) to allow capillary rise through them, reproducing in the laboratory severe conditions of rising damp. After each wetting cycle the samples were dried at 40°C in a ventilated oven. The samples were not brushed between cycles. Salt crystallization was evaluated by visual monitoring and by weighing the specimens daily. The wetting and drying phases in each cycle were prolonged until reaching constant mass.

Figure 3. Dissolution-crystallization cycles: a) partial immersion of mortar samples in sodium chloride solution; b) drying of mortar samples.

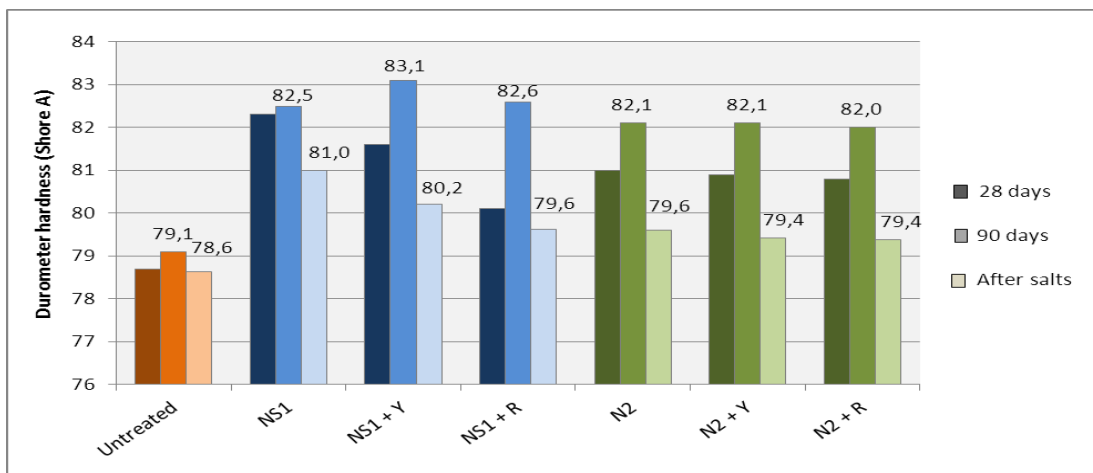
Figure 4 shows the results obtained and the corresponding hardness values obtained with the application of each consolidant and after mortars contamination with NaCl. All consolidation treatments provide increased hardness at 28d, compared to the untreated mortar. At 90 days after treatments, NS1 provides an average increase of 3.6 degrees Shore A and N2 an average increase of 3.0 degrees Shore A. Regarding contaminated mortars, the values are lower than those at 28 days but always higher than untreated mortar values. The presence of salts causes a decrease in superficial hardness, which is of 2.4 degrees Shore A for the NS1 and of 3 degrees Shore for N2. It can also be remarked that NS1 is the consolidant product presenting higher superficial hardness and greater resistance to salts.

Figure 4. Evaluation of durometer hardness with ageing and after NaCl crystallization cycles.

Mechanical results, evaluated through durometer hardness, evidenced some differences between the two products; the highest mechanical increase was obtained with NS1, which however presented a slightly increase in water permeability. Instead N2, probably due to higher concentration of the nanostructured calcium hydroxide, guarantees a moderate water permeability reduction.

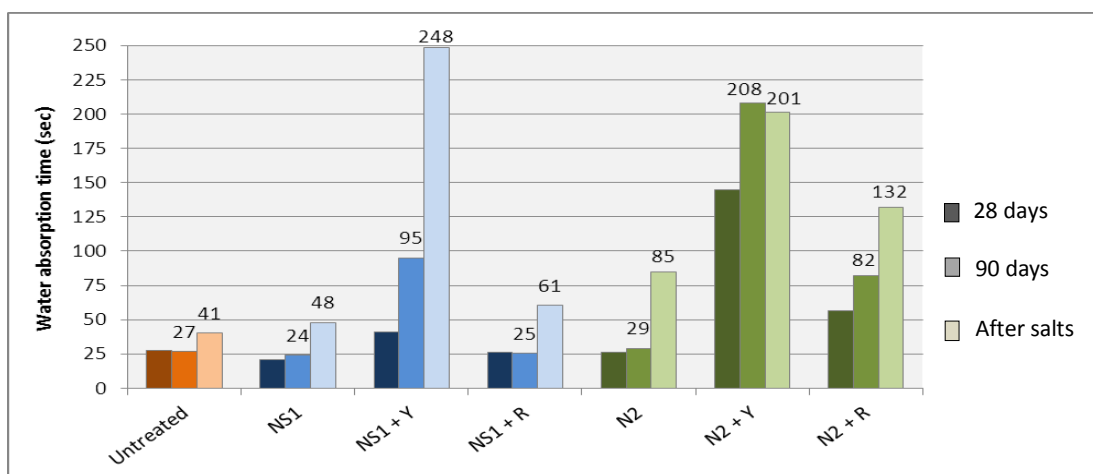
Figure 5. Evaluation of water absorption time with ageing and after NaCl crystallization cycles.

Figure 5 presents the results obtained after consolidation treatments and after salt dissolution-crystallization cycles. Compared to the untreated mortar, not all treatments provide a reduction of water permeability. At 90 days after treatments, the application of NS1 does not provide an increase of water absorption values, meanwhile NS1 + Y illustrates an increased in water absorption of above 5 times. Regarding N2, all results are higher than the untreated mortar, with average water absorption of 6 times. After contamination with NaCl and due to the presence of salts, permeability is reduced for almost all treatments, with greater variation with NS1 + Y treatment. However mortars treated with N2 are those with greater water permeability reduction in the presence of NaCl, with absorption times higher than the NS1. It is also remarked that N2 is the consolidant product that presents the greatest reduction in mortars water permeability, even after crystallization-dissolution cycles.
