## Natural hydraulic lime mortars with ceramic wastes for masonry

FARIA, PAULINA<sup>1</sup>; SILVA, VITOR<sup>2</sup>; MADEIRA, TIAGO<sup>3</sup>

*Keywords:* NHL3.5, ceramic waste, mortar, curing, characterization

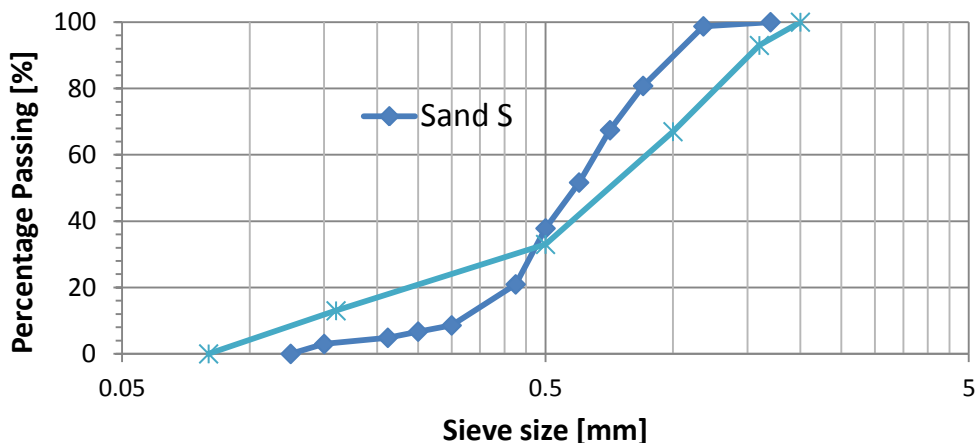
The siliceous washed sand (S) that was used was the same previously used by Grilo et al. [9, 10] and Fontes et al. [13], resulting from a mixture of three graded sands, and the particle size distribution of the mixture of sands, determined by sieving based on EN 933-1 [15], can be found in Figure 1. For comparison the particle size distribution of the CEN standardized sand is also graphically presented.

**Figure 1.** Particle size distribution of the mortars' sand and of the CEN standardized sand

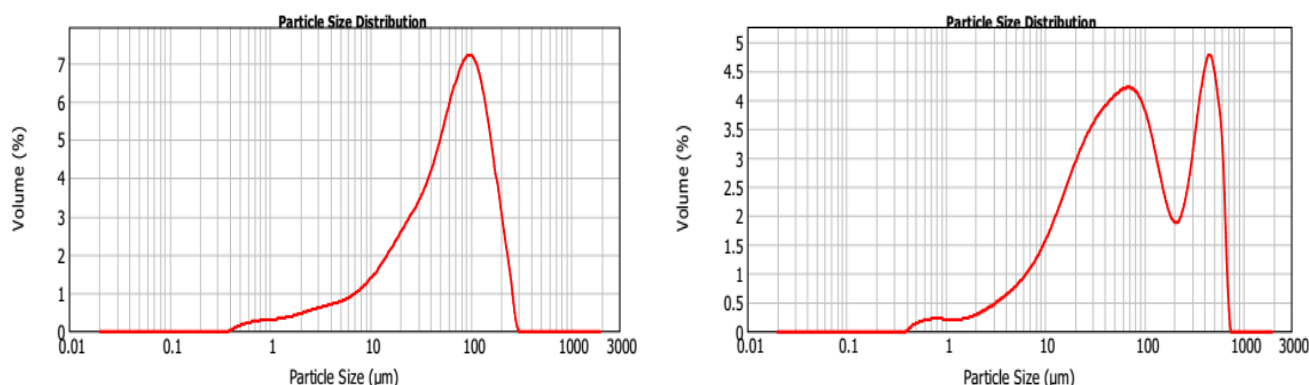
Two ceramic wastes were used, one from broken hollow contemporary bricks (T1) and another from broken contemporary unglazed ceramic façade tiles (T2). The ceramic wastes were crushed and milled; the finer parts were characterized in terms of particle size distribution by laser granulometry using a Mastersizer 2000 equipment (Figure 2).

**Figure 2.** Particles size distribution by laser granulometry of T1 and T2

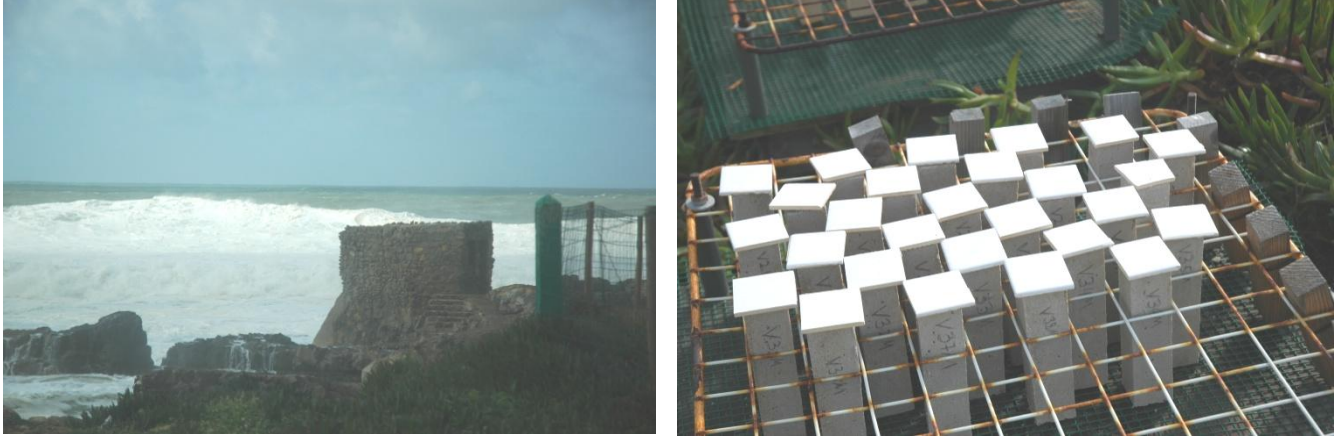
Prismatic 40mm x 40mm x 160mm mortar samples were prepared in metallic moulds with mechanical compaction of each of two layers based on EN 1015-11 [11]. The metallic moulds were removed after two days. All the samples were kept inside polyethylene bags for the first 7 days, following the curing condition established in standard EN 1015-11 [11]. After that period samples of each mortar were kept at 65% RH and 20°C temperature [11] – curing condition St -, while other were exposure to exterior marine conditions, at a distance of about 20 m from the Atlantic coast at Cabo Raso, Cascais,

Portugal (Figure 3 – left) – curing condition M. The prismatic samples were positioned vertically with the top protected by a glazed ceramic tile 50mm x 50mm (Figure 3 - right??). The day before testing, the M samples were transported and kept at St curing conditions for 24 hours, to avoid eventual rainfall over the samples just before testing.

**Figure 3.** Marine curing site at Cabo Raso, Cascais (left) and M samples (right)

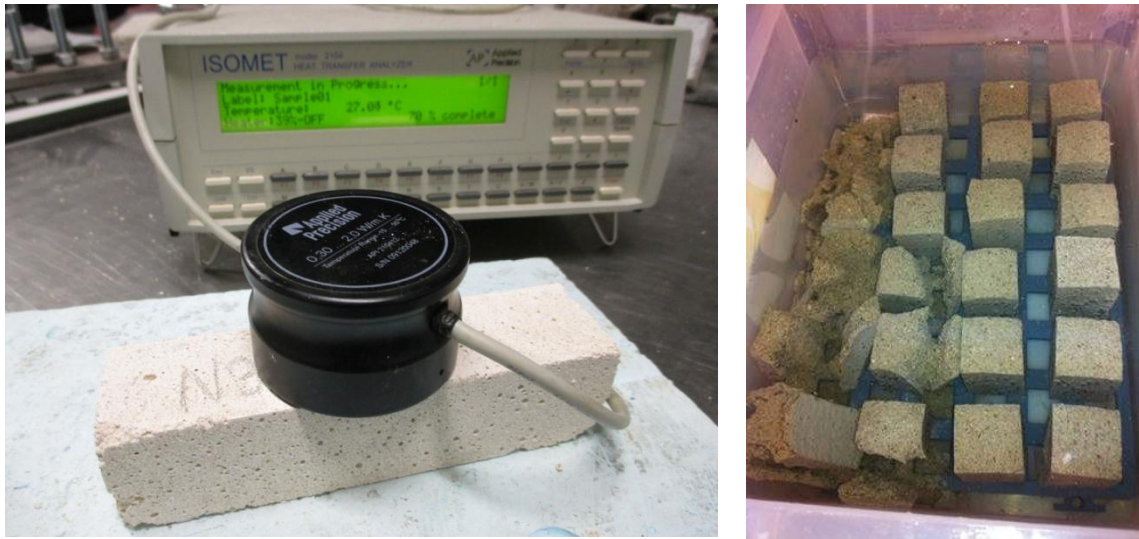
**Figure 4.** Prismatic samples being tested for thermal conductivity (left) and resistance to sulphates (right)

In relation to the thermal conductivity  $\lambda$  of the mortars (Table 4) it must be remarked that not all the probe is in contact with the material because the equipment probe have 6 cm diameter and the samples have 4 cm (Figure 4 – left). Nevertheless the results can be compared between mortars because the dimensions were the same for all mortars. It can be remarked that the thermal conductivity of the ceramic waste mortars is lower than the reference ones, namely at 90 days of age. If the mortars are applied as rendering systems, this property may not have a big influence, as renders are relatively thin (about 2 cm thickness) and the reduction of thermal resistance due to  $\lambda$  decrease will be proportional to the thickness of the mortar layer. In fact, comparing the thermal resistance of a rendering made of NHL mortar without and with 10% of T2 at 90 days of age after marine curing, the thermal resistance can only vary between 0.03 and 0.05 ( $m^2.K/W$ ).

In respect to the resistance to sulphates (Figure 7 and Table 5) it seems that, in general terms, the mortars in laboratory conditions resist more than those in marine environment, both without and with additions (Figure 4 – right – mortar samples at the right part of the test box). That fact can probably be explained by the combination of salts and salted products that may be formed when chlorides are present in the environment (namely in marine environment) and combine with the sulphates. The resistance to sulphates seems to decrease with the increase of T2 addition. The mortars with 10% of both ceramic wastes and with 25% of T1 in laboratory conditions behaved better than the correspondent reference mortar, what can be beneficial, particularly when sulphates contamination exists or is expected.

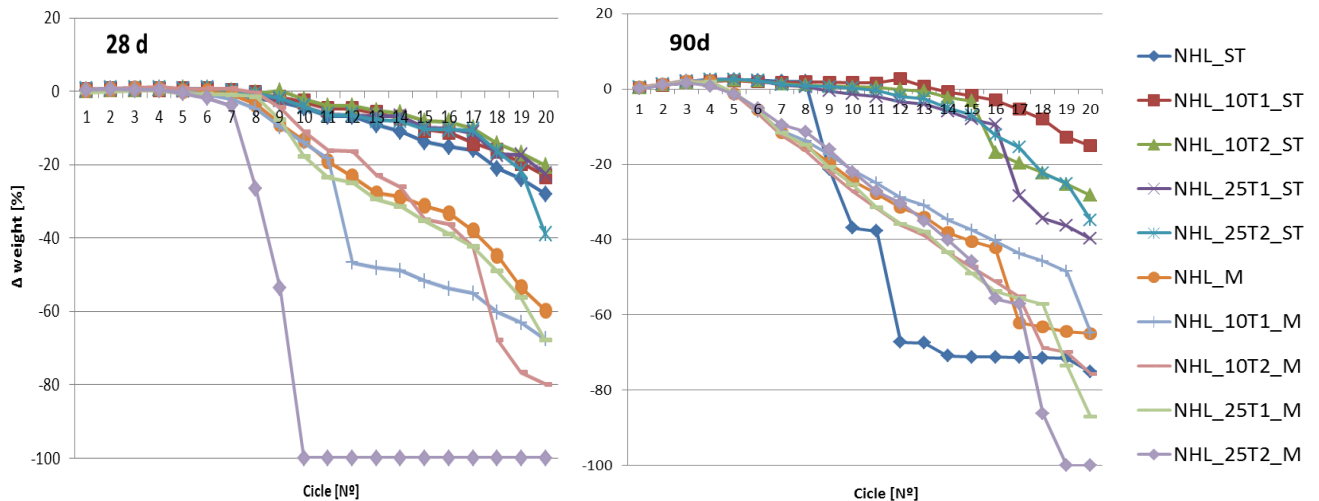
Figure 7. Weight variation due to sulphate test cycles
