**Telma Filipa Ferreira Chito Ribeiro**

Mestre em Conservação e Restauro

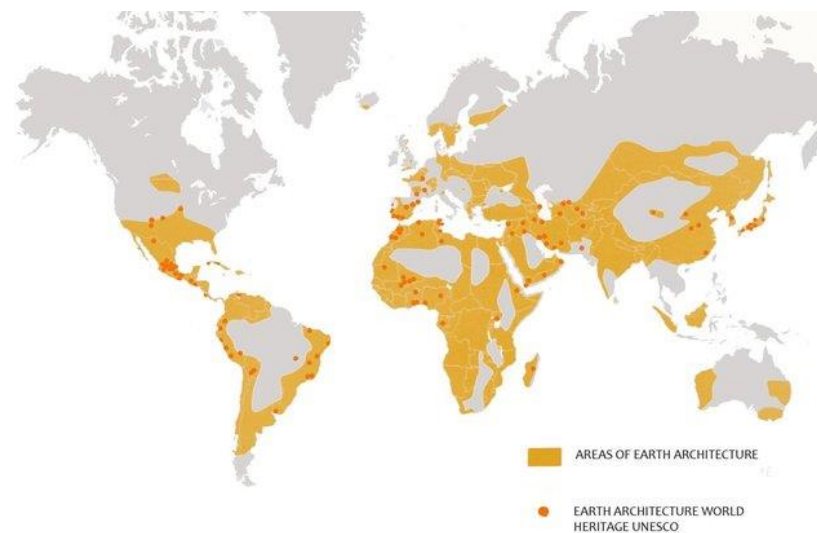
**Figure 1.1:** Earthen construction distribution worldwide (*credits* (Alex 2018)).

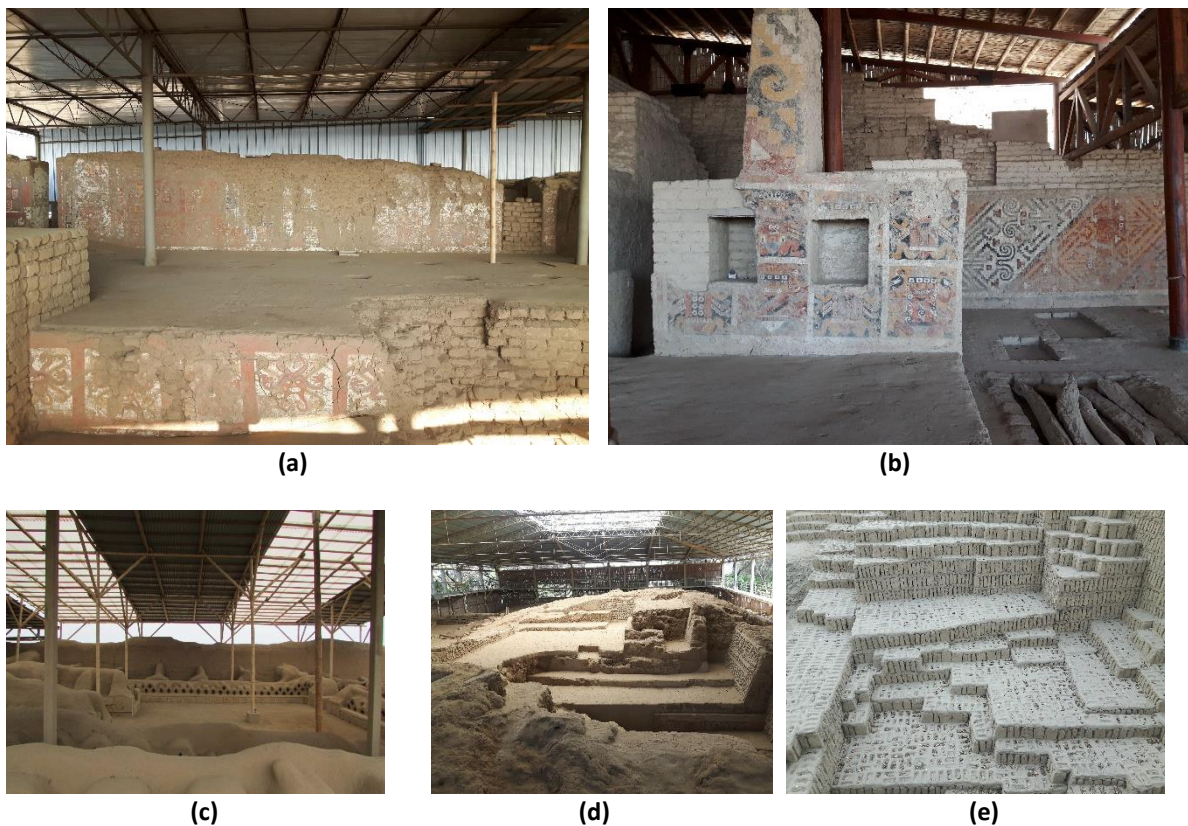
**Figure 2.9:** Earthen archeological sites in Peru. (a) Huaca del Sol, Trujillo. (b) El Brujo, Trujillo. (c) Chan Chan, Trujillo. (d) Túcume, Chiclayo. (e) Huaca Pucllana, Lima.

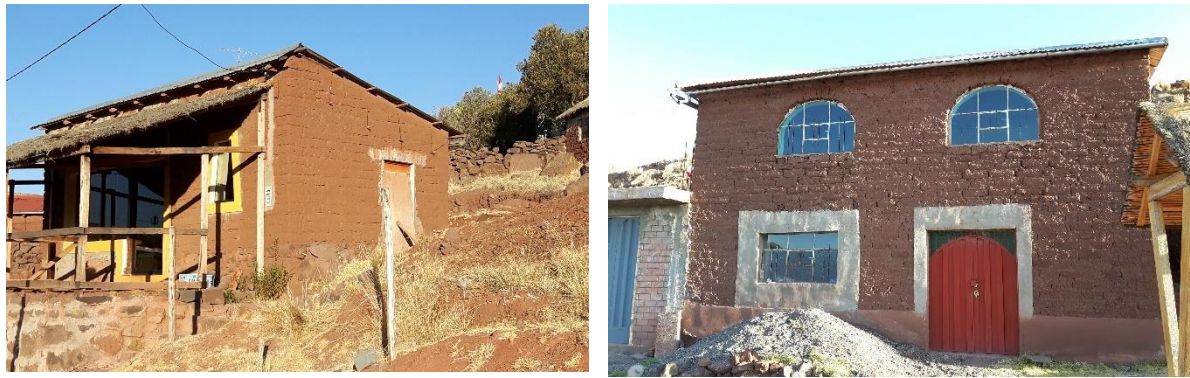
**Figure 2.10:** Two examples of modern construction in the southern region of Peru.

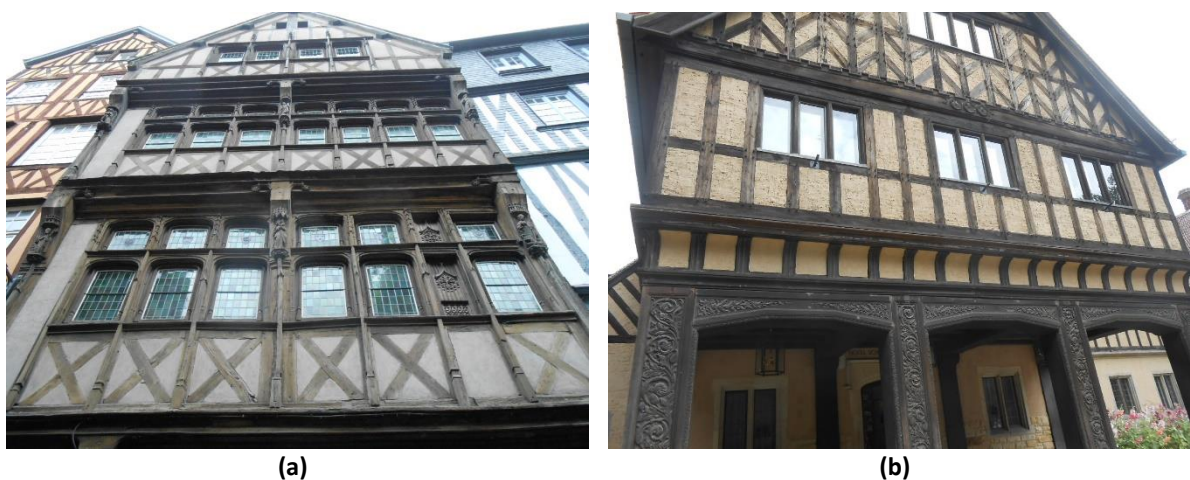
**Figure 2.12:** Example of earth used as infilled material in a timber structure. (a) Rouen, France; (b) Potsdam, Germany.

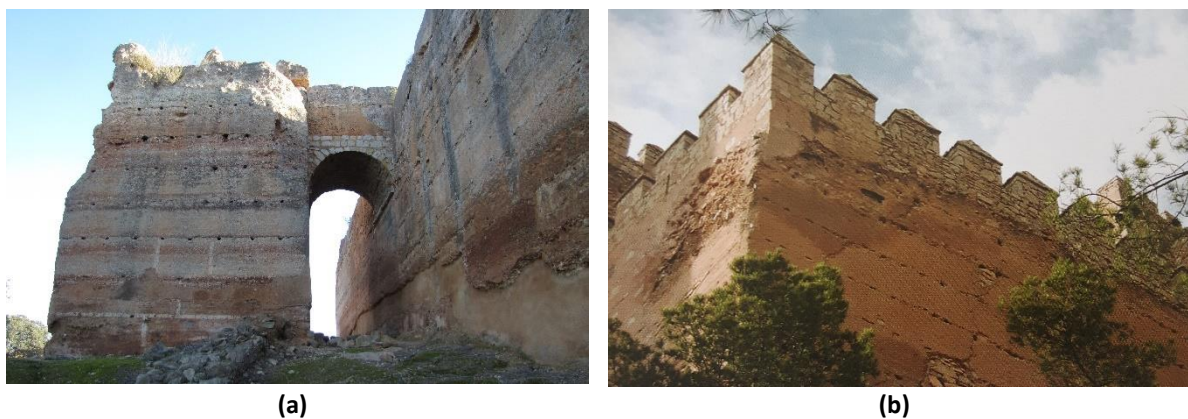
**Figure 2.13:** Examples of monumental construction with earth in the Iberian Peninsula. (a) Paderne Castle, Portugal (credits: Daniel V. Oliveira); (b) Almansa Castle, Spain (credits: (Mileto and Vegas 2014)).

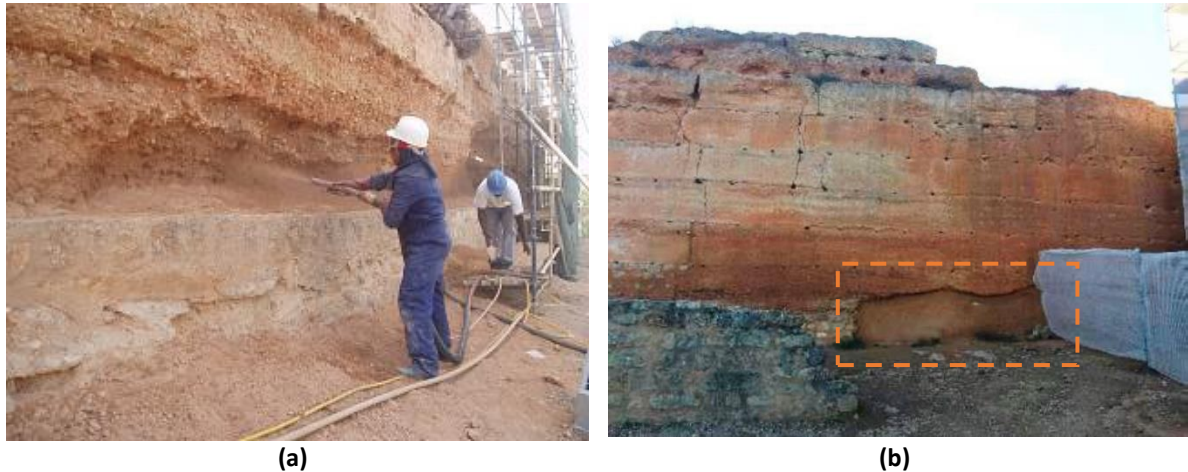
**Figure 3.1:** Paderne Castle: (a) technique of projected earth done in the intervention in 2004/2005 (credits: <http://castelodepaderne.blogspot.com/2011/02/castelo-de-paderne-aquando-do-restauro.html> accessed on 16-Apr-2020); (b) present visual aspect of the area where the projected earth technique was applied, marked with the orange dotted area (credits: Mafalda Cotrim (Cotrim et al. 2018)).

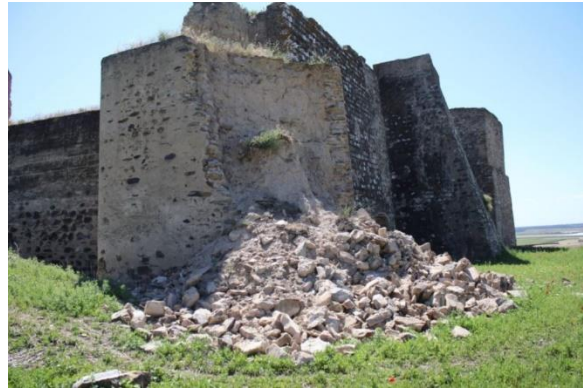
**Figure 3.2:** Tower of Juromenha Castle that collapsed in 2008 (source (Dias 2018)).

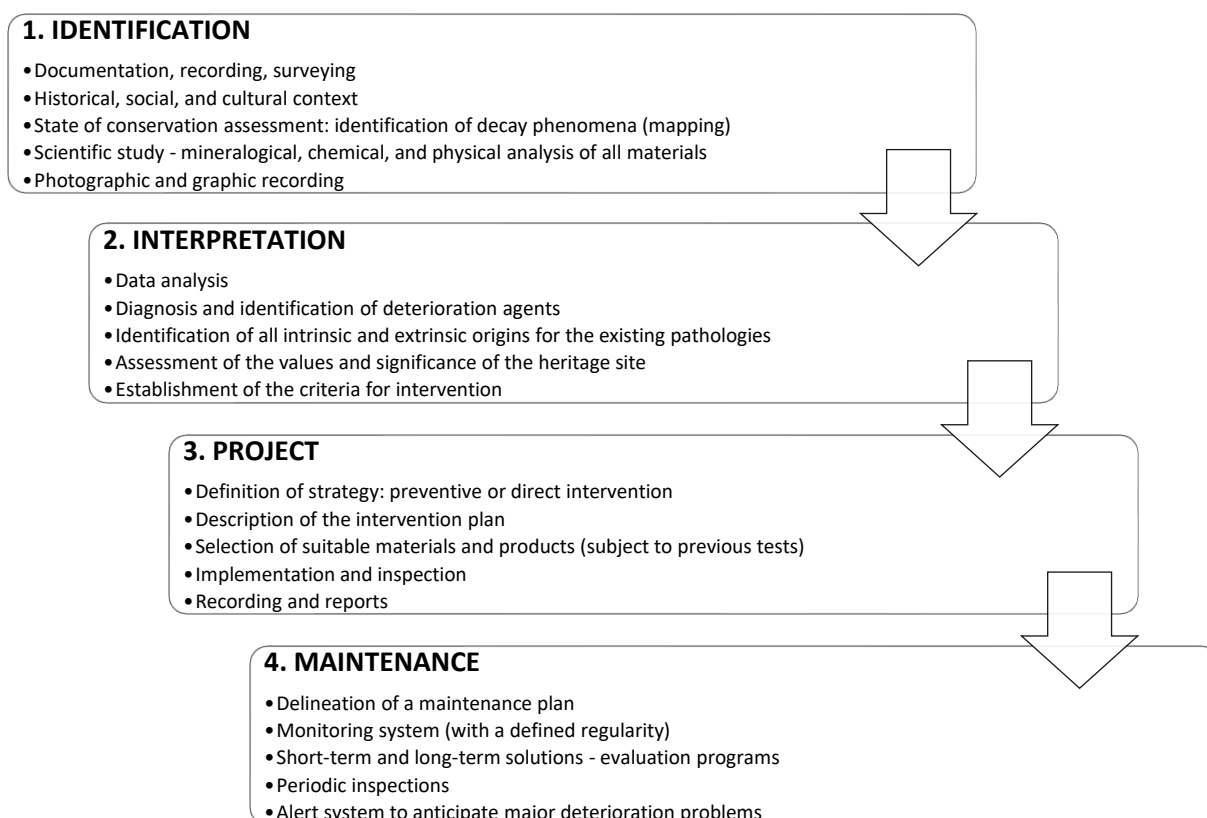
Even though this methodology is widely known among conservators, the application is deficient in practical cases, especially on earthen heritage. As previously exposed, maybe due to the lack of specific guidelines, property managers do not follow this approach when dealing with a conservation project. Therefore, the methodology previously presented steps can constitute a powerful tool to be employed on any earthen heritage property since it is possible to adapt to the particularities of all cultural sites. Moreover, it is within the framework of international charters and recommendations that regulate interventions on cultural objects.

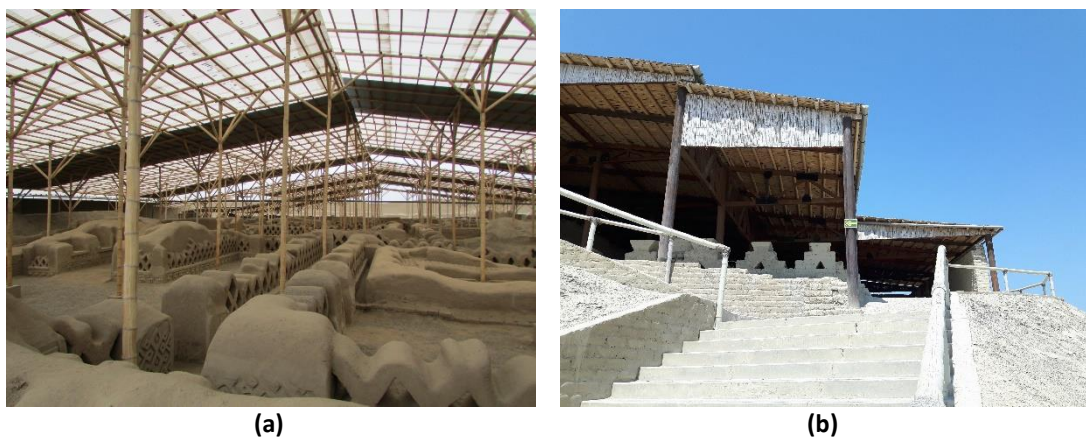
**Figure 3.5:** Shelters on Peruvian archaeological sites: (a) Chan Chan, Trujillo; (b) El Brujo, Trujillo.

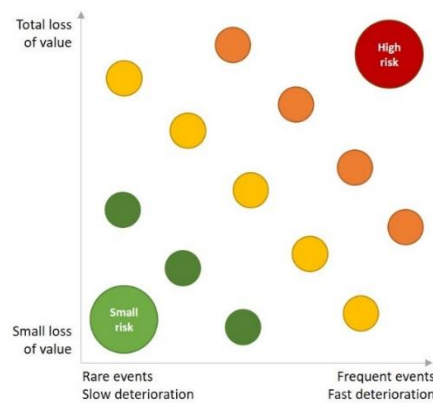
**Figure 3.6:** Risk Analysis based on the method proposed by ICCROM and CCI (Michalski and Pedersoli Jr 2016).

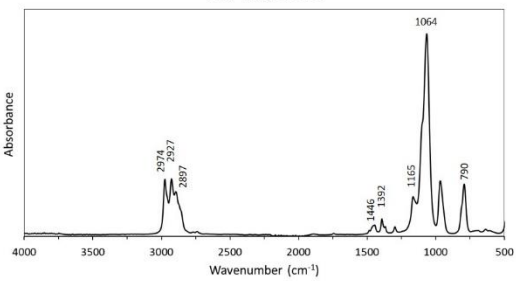
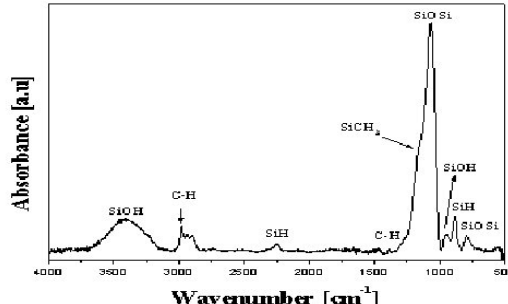
<p>(reference: (Guermat et al. 2011))</p>
	<p><b>Identified bands</b></p> <ol style="list-style-type: none"> <li>1. <math>2974\text{ cm}^{-1}</math> to <math>2897\text{ cm}^{-1}</math>: C-H stretching</li> <li>2. <math>1446\text{ cm}^{-1}</math>: <math>\text{CH}_3</math> asymmetrical bending</li> <li>3. <math>1392\text{ cm}^{-1}</math>: <math>\text{CH}_3</math> symmetrical bending</li> <li>4. <math>1165</math> and <math>1064\text{ cm}^{-1}</math>: asymmetric Si-O-Si stretching</li> <li>5. <math>790\text{ cm}^{-1}</math>: Si-O-Si bending</li> </ol>	
Nanoparticles of silica	<p><b>FTIR - Nanoparticles of silica</b></p>

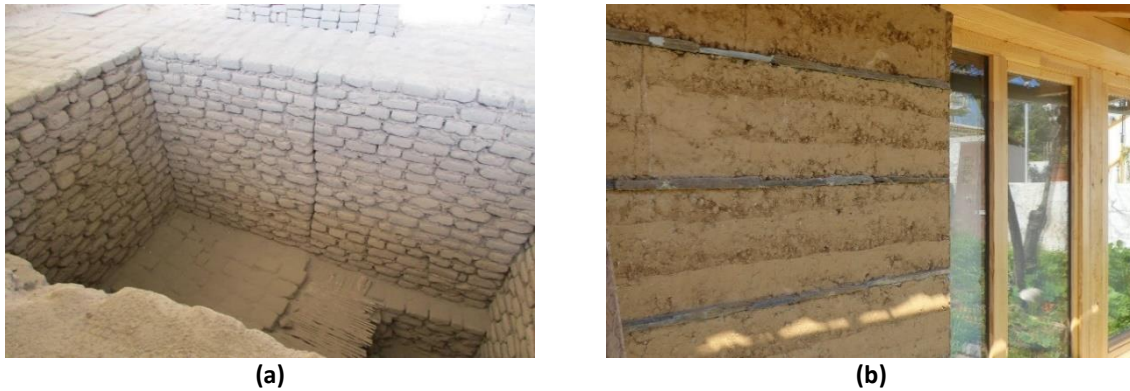
**Figure 4.13:** Example of adobe and rammed earth constructions to demonstrate the usual surface that is exposed in real case scenarios; (a) archaeological adobe structure in Huaca de la Luna, Peru; (b) rammed earth wall in new construction in Alentejo, Portugal.

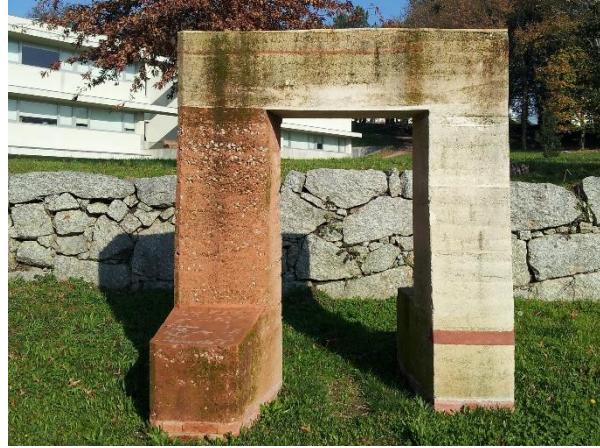
**Figure 6.1:** The case study - Rammed Earth Installation at the University of Minho.

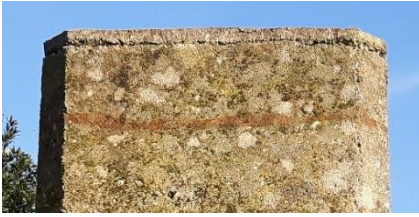
<i>Deterioration phenomena</i>	<i>Example in the Case Study</i>	<i>Drawing pattern</i>
CRACKING

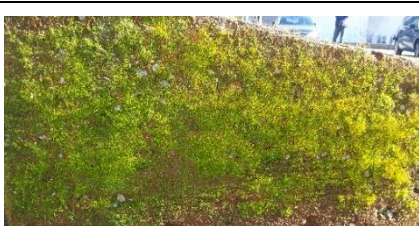
### 6.3. Project: conservation practice

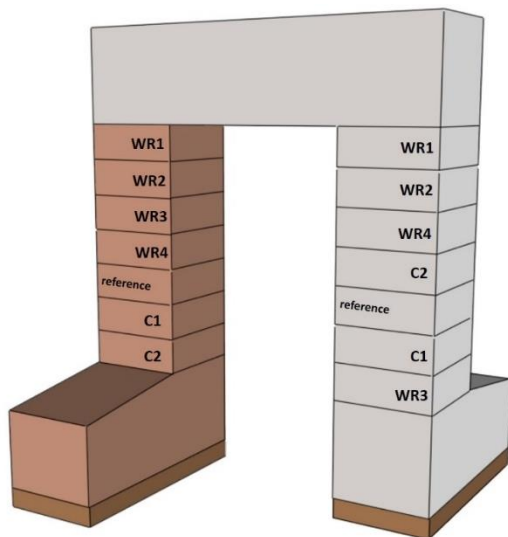
**Figure 6.9:** Representative sketch of the Rammed Earth Installation with the indication of the sections where the two consolidants and the four water repellents were applied (C1: Ethyl silicate; C2: Arabic gum; WR1: Siloxane; WR2: Aquashield; WR3: Linseed oil; and WR4: Beeswax).

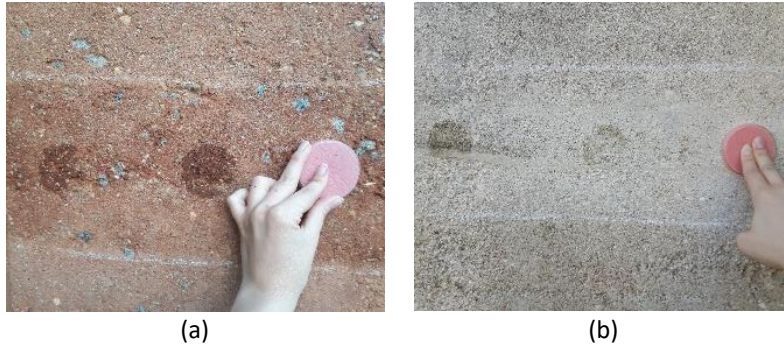
Figure 6.12: Contact sponge method performed *in situ* on both unstabilized and stabilized columns.

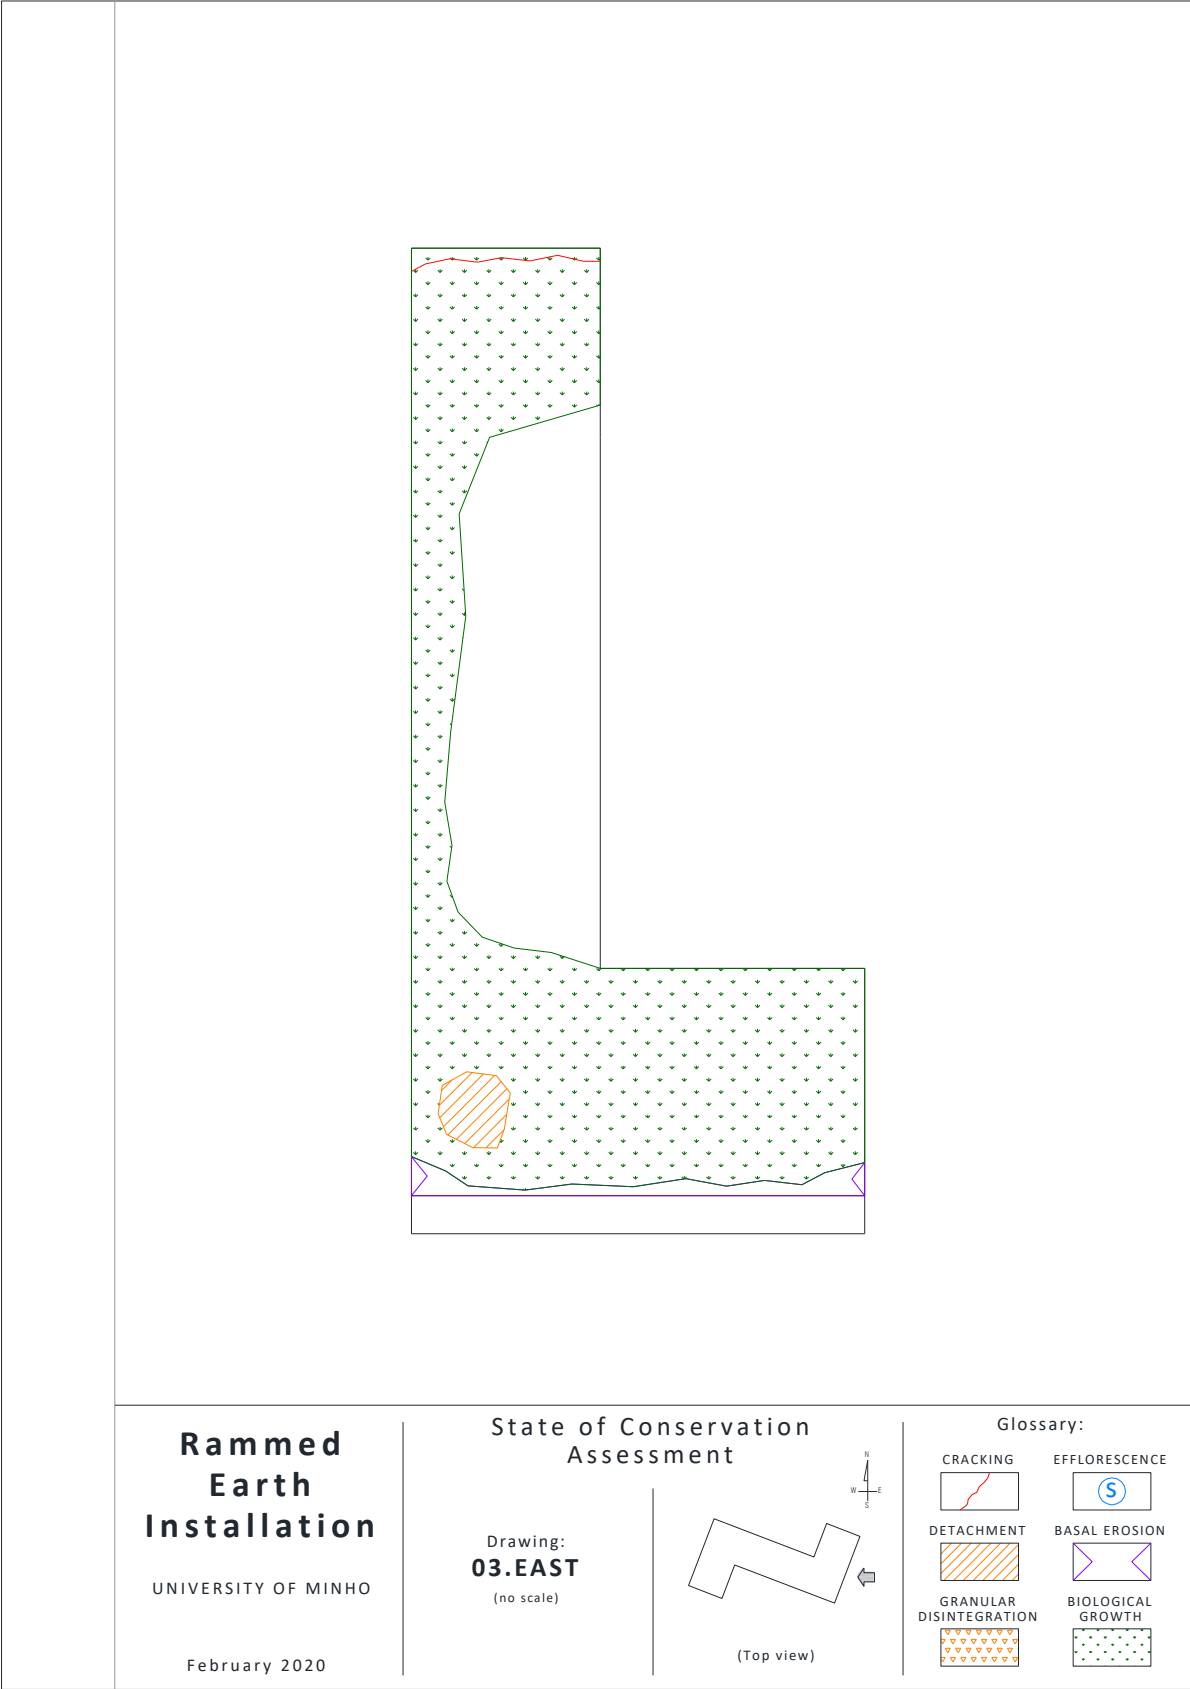
**Rammed  
Earth  
Installation**

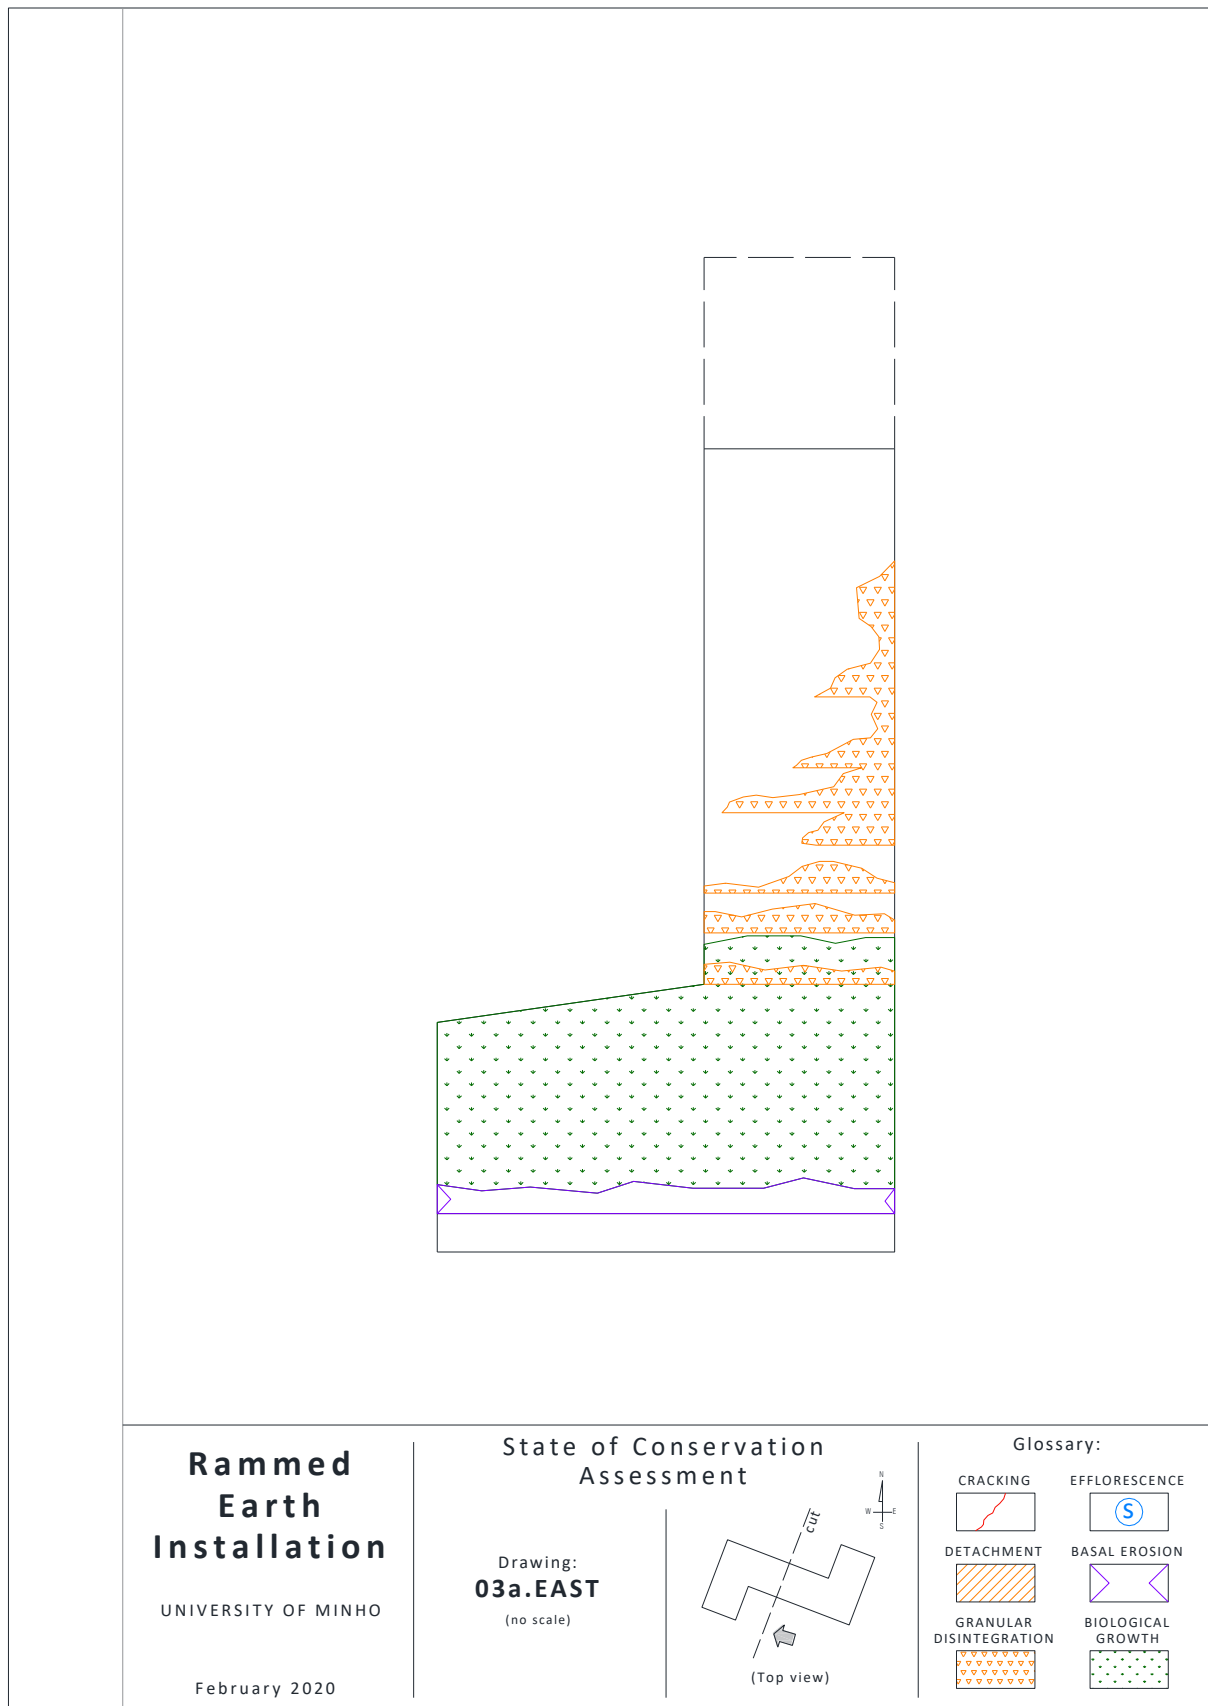
Mapping of degradation phenomena (West view).
