# Troia Roman Baths (Portugal) – Assessment of history of interventions

**SUMMARY:** *This paper presents a study of one of the roman architectonic complexes from Troia archaeological site: the Roman Baths. The first archaeological excavations campaigns and the different Roman monuments that constitute the whole site are presented, as well as the historical past conservation and restoration interventions and the most important decay factors. The Roman Baths are one example of a complex that has been intervened in, at least, two different periods of time. An assessment was made in order to understand and document its actual state of conservation, to help planning a future coherent conservation operation.*

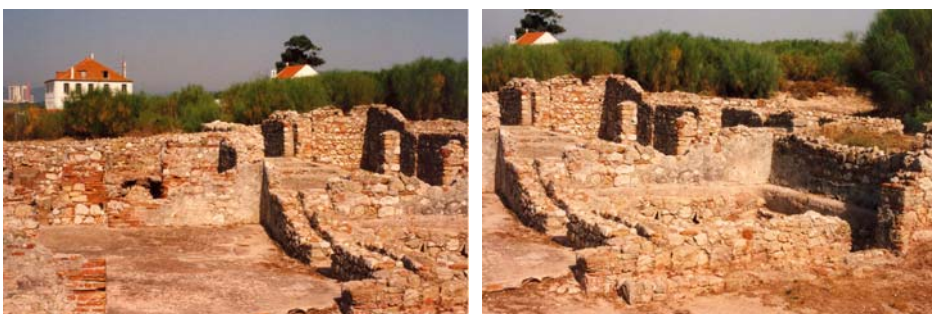
Figs. 1 and 2 – General view of the Roman Baths area

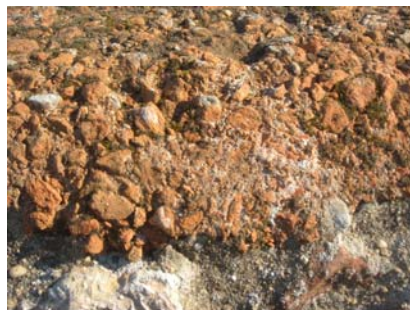
Fig. 6 and 7 – Cistern render (*frigidarium*) and detail of the *opus signinum*

The central room has an irregular square plan: 6,44m S, 6,76m N, 6,43m W and 6,21m E, covering approximately an area of about 43,53 m<sup>2</sup>. The floor is decorated with mosaic; the interior walls are rendered with a grey mortar; covered with mural paintings, with geometric motives in red and yellow. These decorative motives are similar to other found in the *apoditherium*, revealing some homogeneity in decoration.

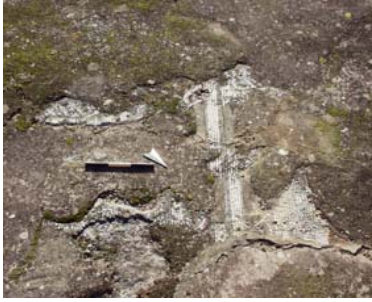
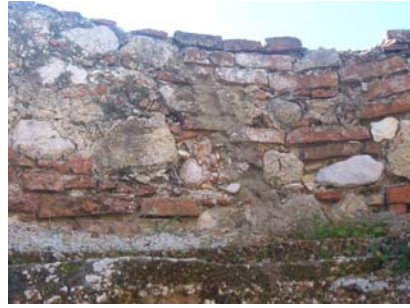
Figs. 8 and 9 – Two examples of Roman ancient interventions.

Various Roman interventions can be identified, with very similar approaches and objectives. Floor covering reformulations was carried through a late Roman period [2], eventually for guarantee its constant use. Some different materials (mortars) were applied over the ancient ones. It happened in the interior of the circular swimming pools (*caldarium* and *frigidarium*) where ruptures and waterproof problems probably existed. The solution adopted constituted in the application of thick layers of a coarse hydraulic mortar based on hydrated lime, with brick powder and fragments as a major component (*opus signinum*). Other example of a Roman repair can be observed in the *frigidarium* floor. The floor was primitively covered by an *opus tessellatum* pavement and due to its use or other occurrence, it was subjected to intervention. Two different types of repair can be registered: one similar to the former, where 80% of the floor had been overlapped by a fine grained *opus signinum* plaster and other where some missing parts of the mosaic pavement were mended by a coarse grained mortar.

Those interventions could eventually be contemporaneous since the materials used have much in common (the chosen materials are characterized for being a mortar with the same characteristics). However this introduction of new materials resembles to be a purely functional intervention, having the initial structures lost its primitive aesthetic enchantment.

After a first analysis, based only in an accurate visual observation, it is possible to say that all the carried interventions during Roman times present a adequate behavior since there is still a good adhesion between the repair mortar and the original substrate. No signs of fissuring were observed. In an aesthetical point of view, these repairs did not respect the original structure and its authenticity, occulting them and devaluating it. The systematic use of a hydraulic mortar could be eventually connected with durability and functionality aspects.
