Historic timber roof structures

Dissertação para obtenção do Grau de Mestre em
Engenharia Civil – Estruturas e Geotecnia

4.2.1 – Structural geometry	62
4.2.2 - Roof deterioration state.....	66
4.3 - Actions.....	73
4.3.1 - Permanent actions	73
4.3.2 - Imposed load.....	73
4.3.3 – Snow	73

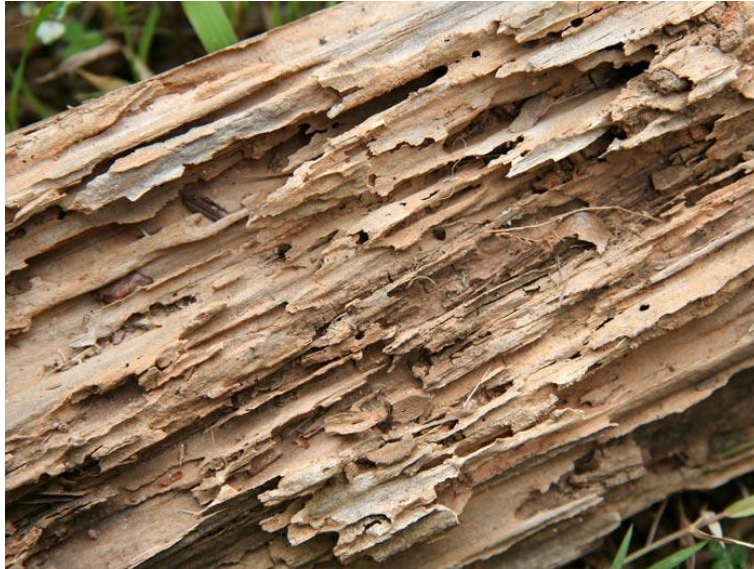
Fig. 3.2 – Termite attack [4].

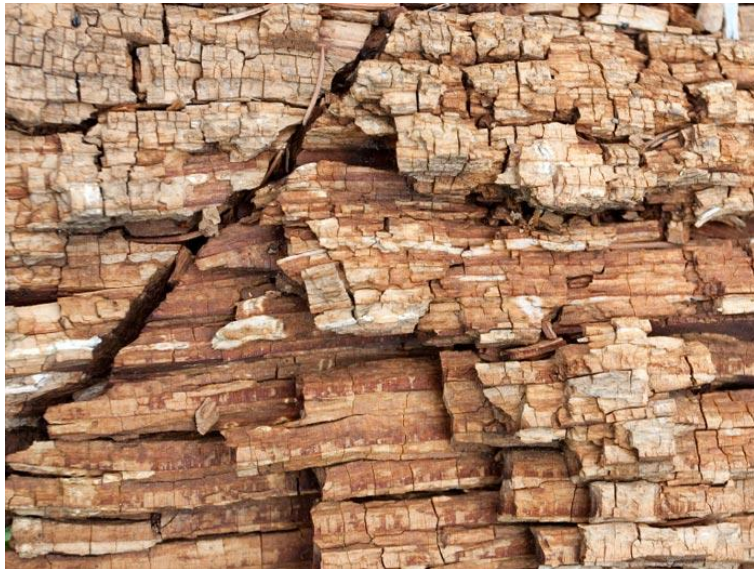
Fig. 3.3 – Brown rot [4].

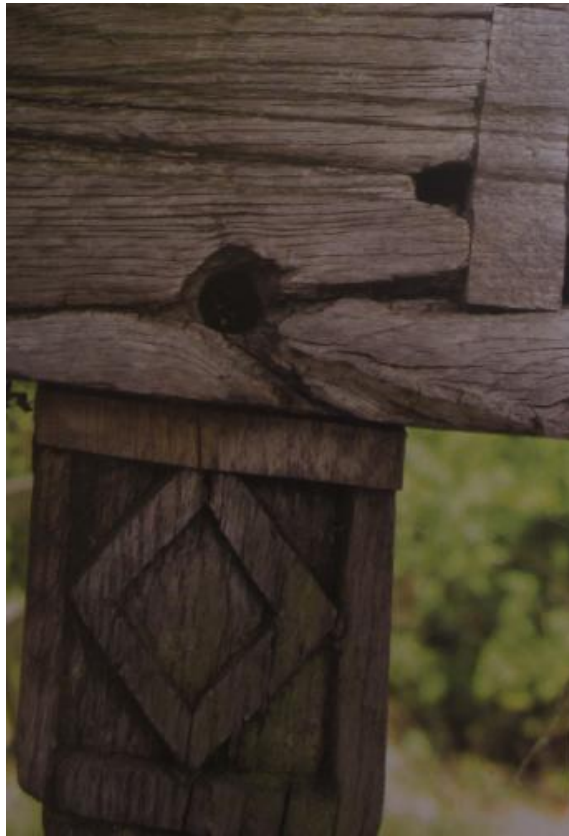
Fig. 3.5 – Light modifies wood surface, turning it silver-grey. When combined with external elements, it can create small surface splits and cracks [1].

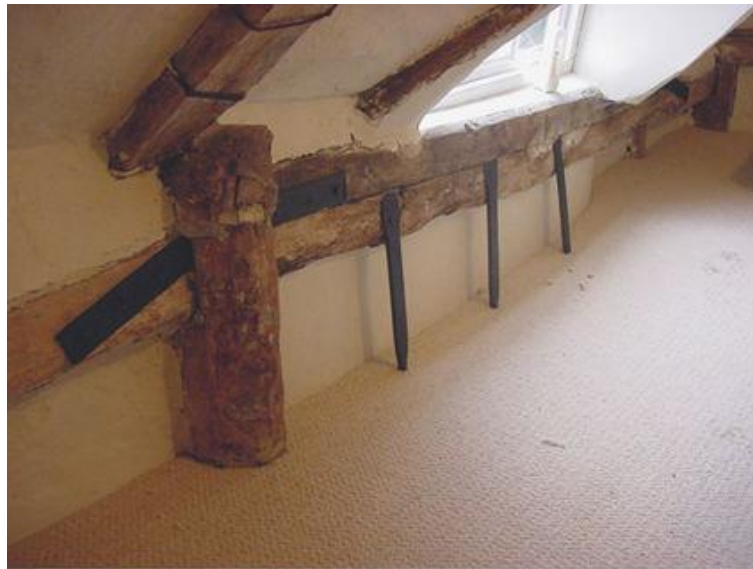
Fig. 3.7 – Copious ironwork was amateurishly inserted to arrest its collapsing floors and splaying walls [3].

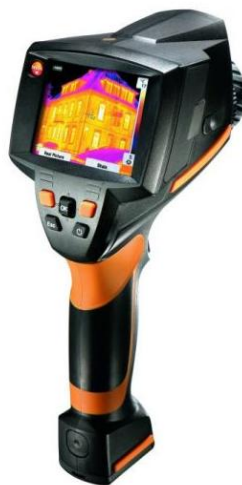
Fig. 3.10 – Thermographic camera [72].

When under the same environmental conditions, a homogeneous material temperature distribution is uniform, what means that substantial temperature differences shown by thermographic camera can be evidence from deterioration, structural defects, voids, damp conditions (Fig. 3.11), insect attack (Fig. 3.12) or hidden connections. Bigger temperature differences can indicate deeper defects [49].

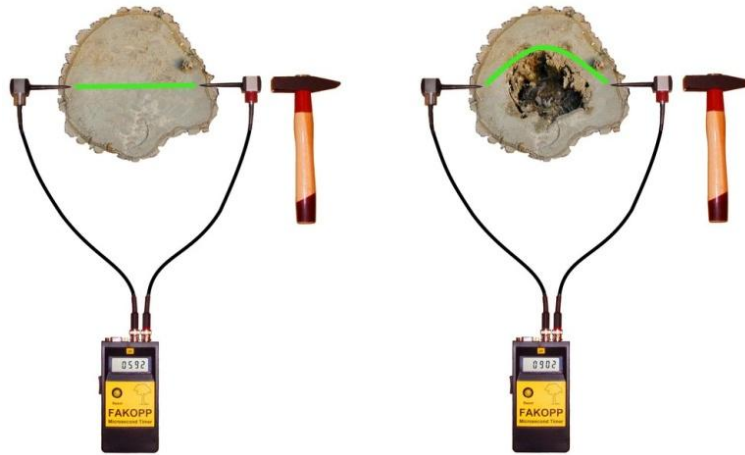
Fig. 3.14 – Fakopp device - Acoustic wave propagation in clear and decayed trunk [27].

Another wood property to be measured can be by the attenuation of the wave propagation in the material. A wood degraded by fungus, for example, absorbs more of the wave energy than not an infected one [18].

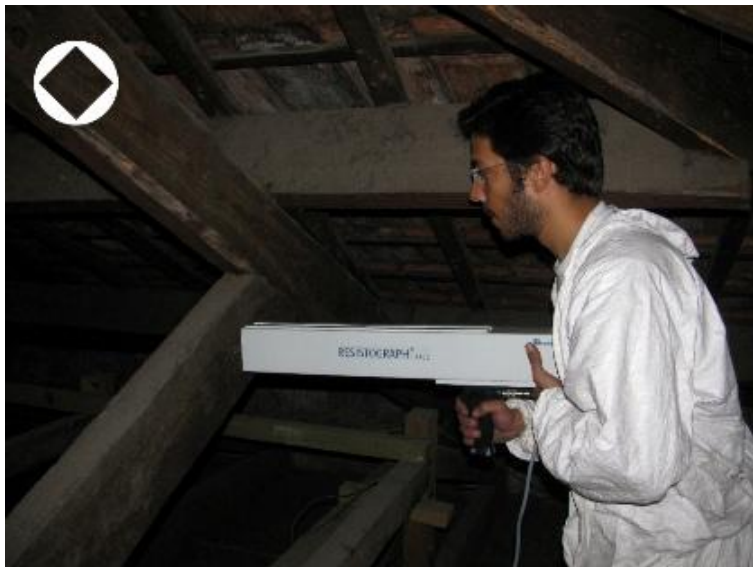
Fig. 3.15 – Resistograph [50].

The resistograph (Fig. 3.15) is an instrument with a similar action to a drill with small drill bits $\phi_{\max}=3\text{mm}$. As the drill enters the element, depending on the resistance offered by the wood and the progressive penetration of the drill bit, it is possible to identify a typical density variations as well as physical discontinuities like cracks or biological attacks through graphic interpretation (Fig. 3.16) [30,41,70].

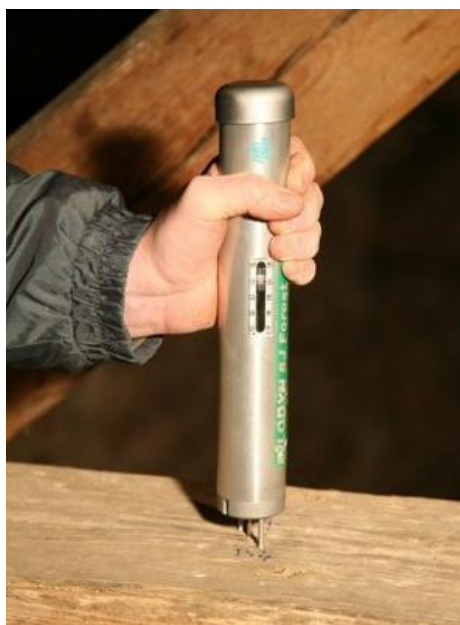
Fig. 3.17 – Pilodyn [14].

This is a simple, quick and not expensive test, which can be done and analyzed in situ. However for better results, several tests should be completed and compared to others done in similar conditions.

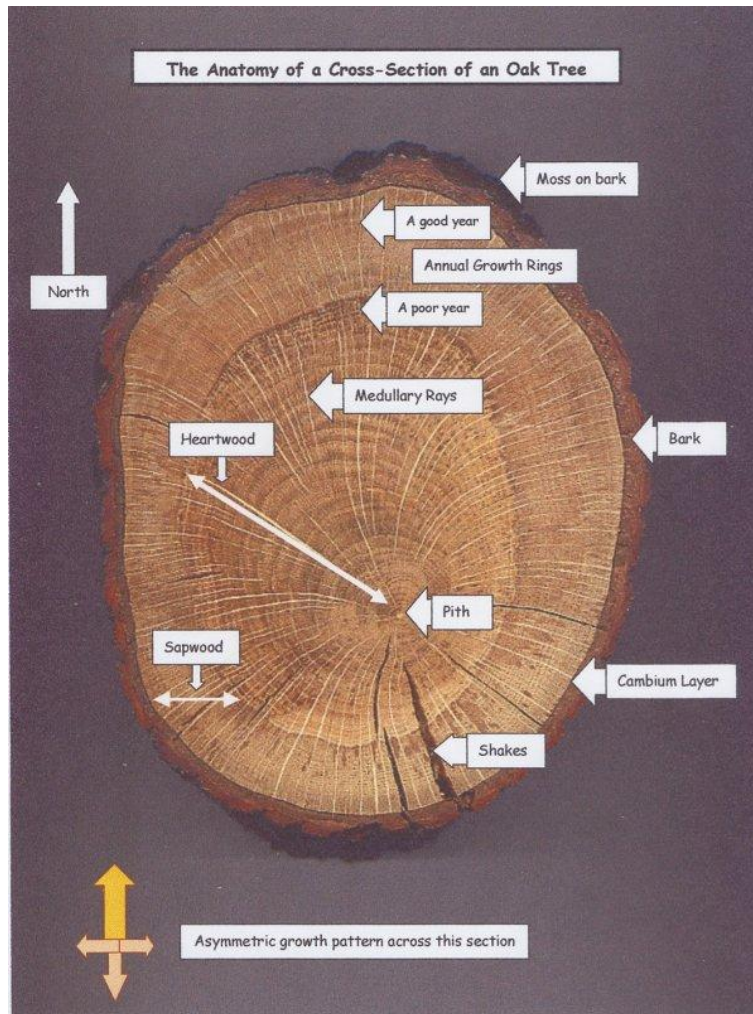
Fig. 3.22 – Anatomy of a cross-section of oak [73].

Simplistically, trees from the same specie growing in the same geographical region exposed to the same conditions tend to develop the same unique way. Based on that, the method consists of the study of the ring growth patterns (see Fig. 3.22), measuring the variations of the timber trunks cross section thickness and comparing and identifying it with a reference chronology database (if one exists) [7].

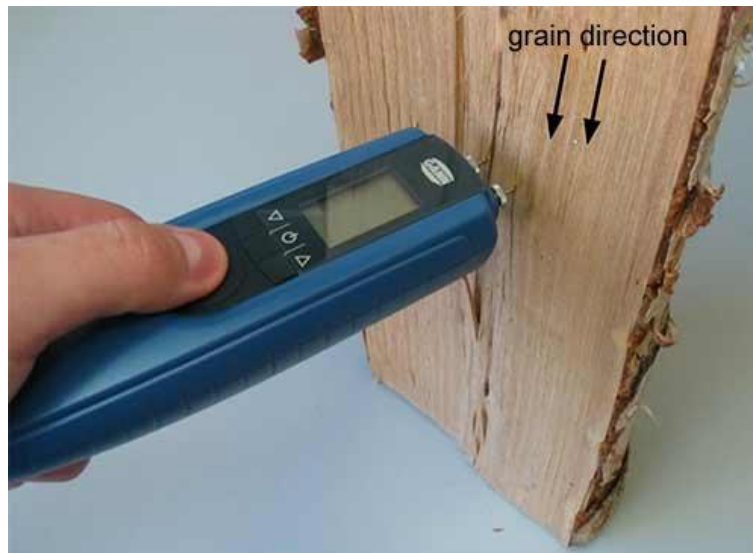
Fig. 3.23 – Hygrometer [55].

Although hydrometers are not designed to detect deterioration, it is recommended as a first method to use in areas where there are suspicions, since moisture contents above the fibers saturation point indicate proper conditions for deterioration development.

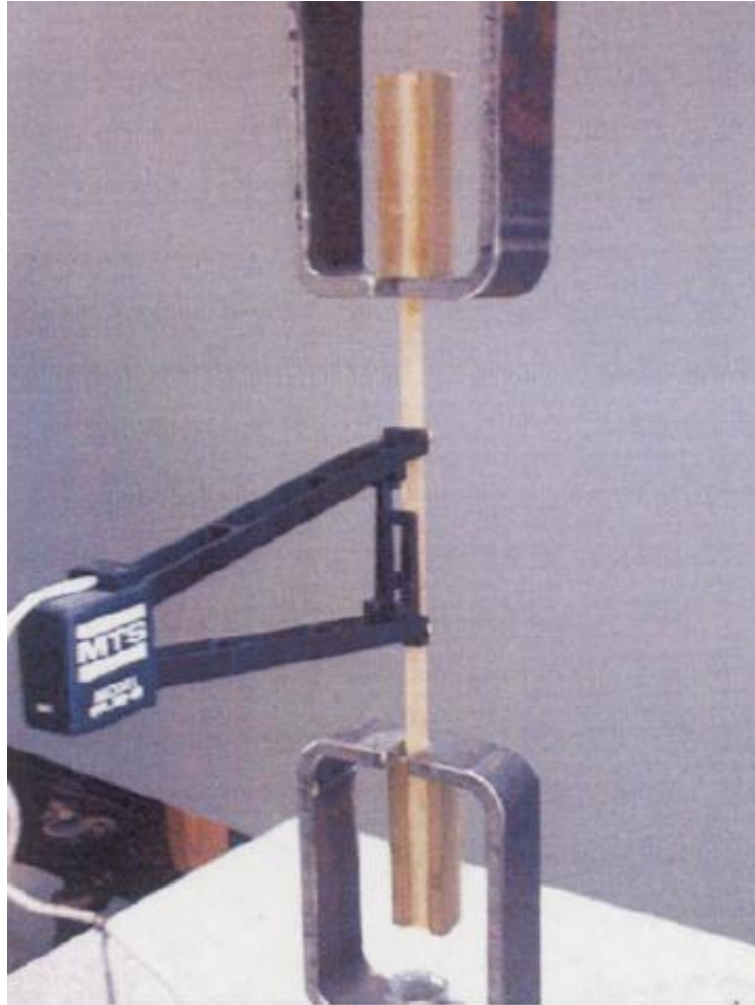
Fig. 3.26 – Testing of the tensile micro-specimen. The central portion defining the gauge length is machined to a smaller cross-section [41].

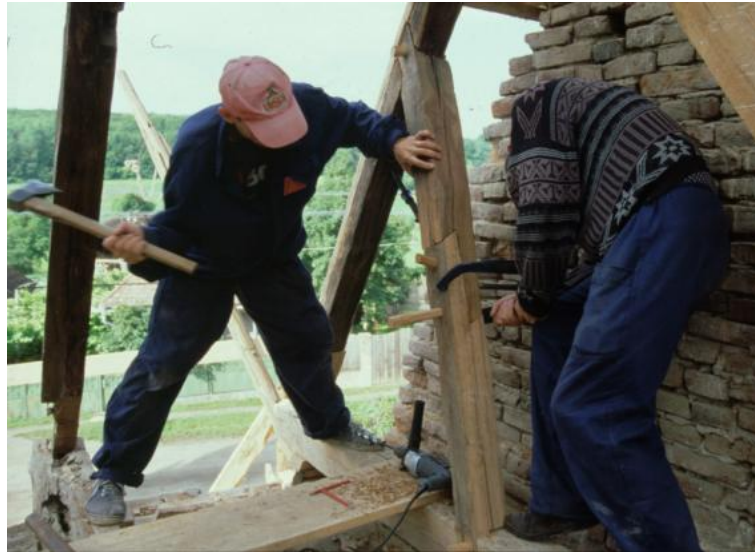
Fig. 3.27 – Timber to timber repair in situ.

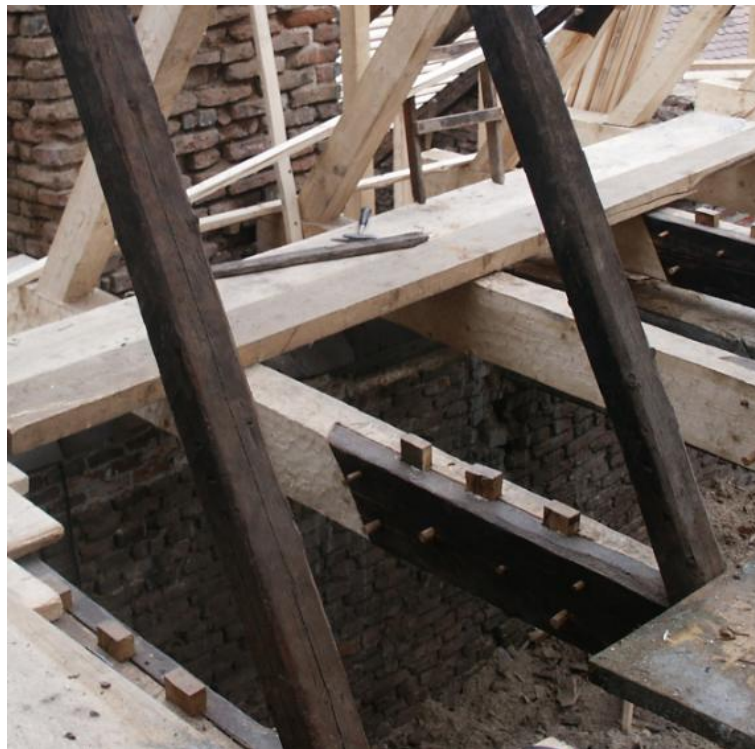
Fig. 3.28 – Old – new timber to timber connection.

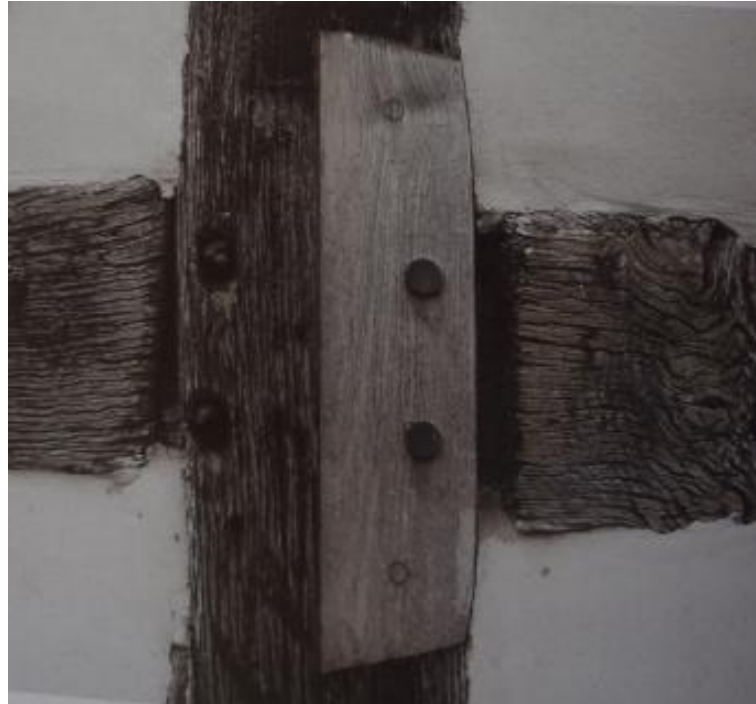
Fig. 3.34 – Face repair [1].

These recommendations are not only to maintain the original content or to preserve the heritage values but also to make sure that both, old and new timber, will have a similar movement with moisture changes or external actions.

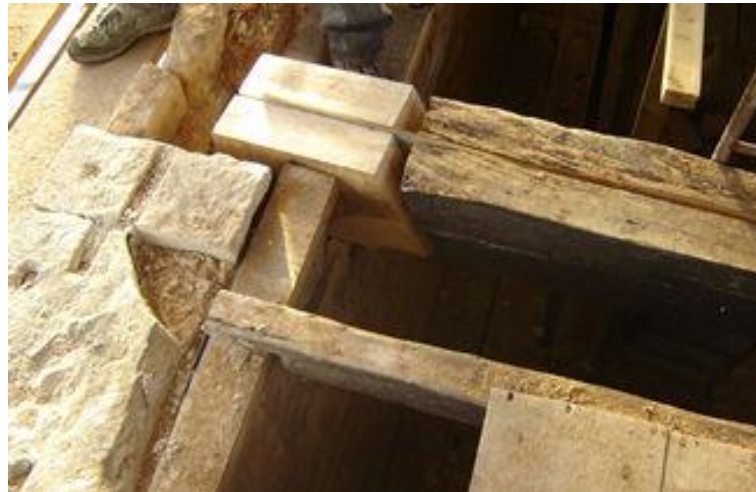
Fig. 3.35 – Flitch plate intervention [1].

Figs. 3.35 to 3.38 show some examples of steel usage in timber repair. The first one (Fig. 3.35) is a flitch plate intervention, the second one (Fig. 3.36) are some reinforcements in the connection between elements, the third (Fig. 3.37) is a structural reinforcement of the structure with additional metallic elements and the last one (Fig. 3.38) represents structural reinforcement through metallic cables.

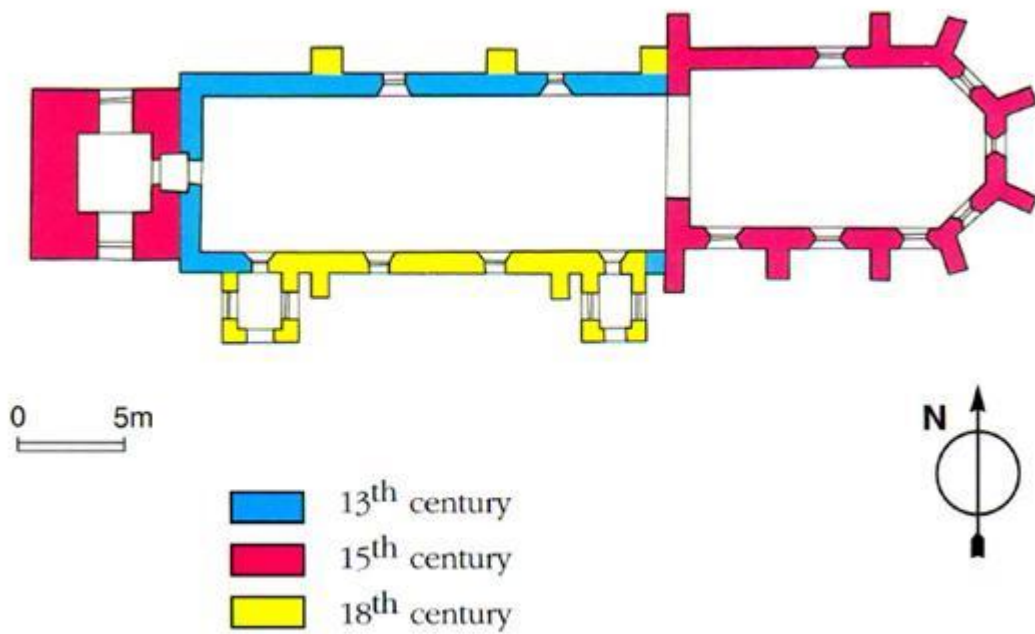
Fig. 4.4 – Church ground plan construction dates
(based on [56])

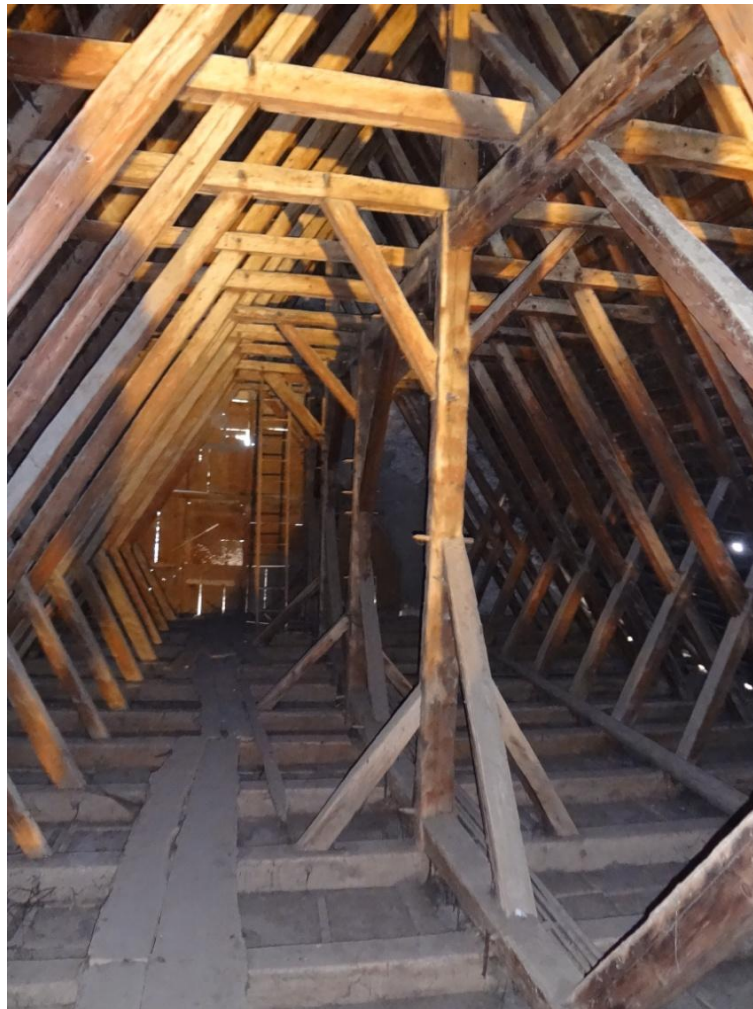
Fig. 4.12 – Structural layout.

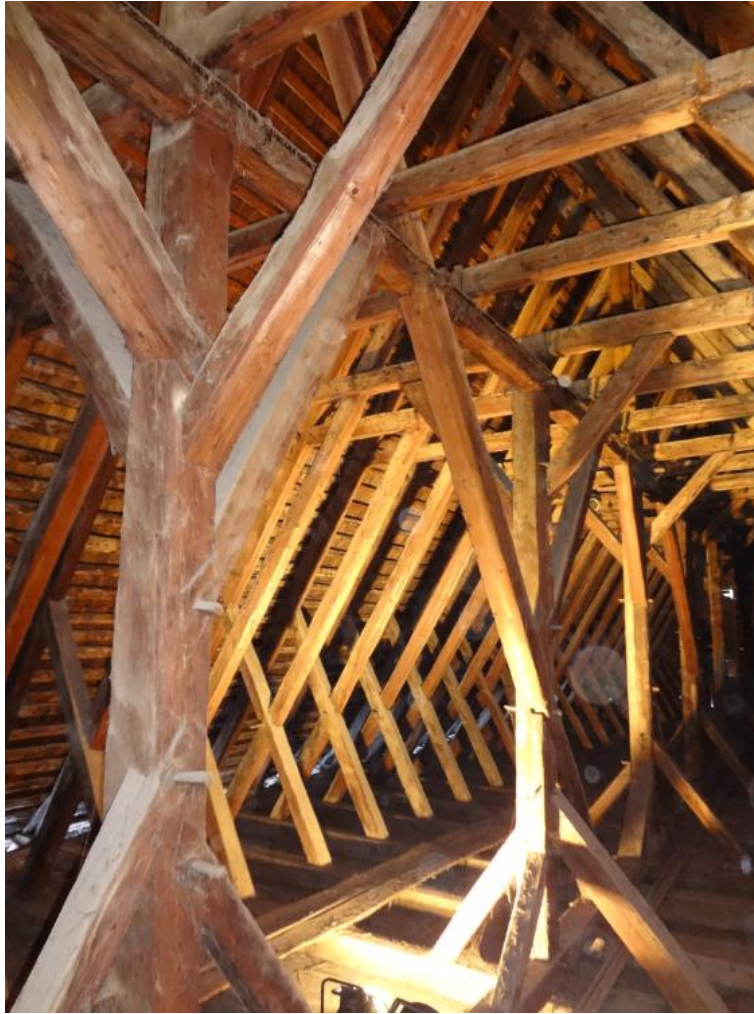
Fig. 4.13 – Tridimensional aspect in situ

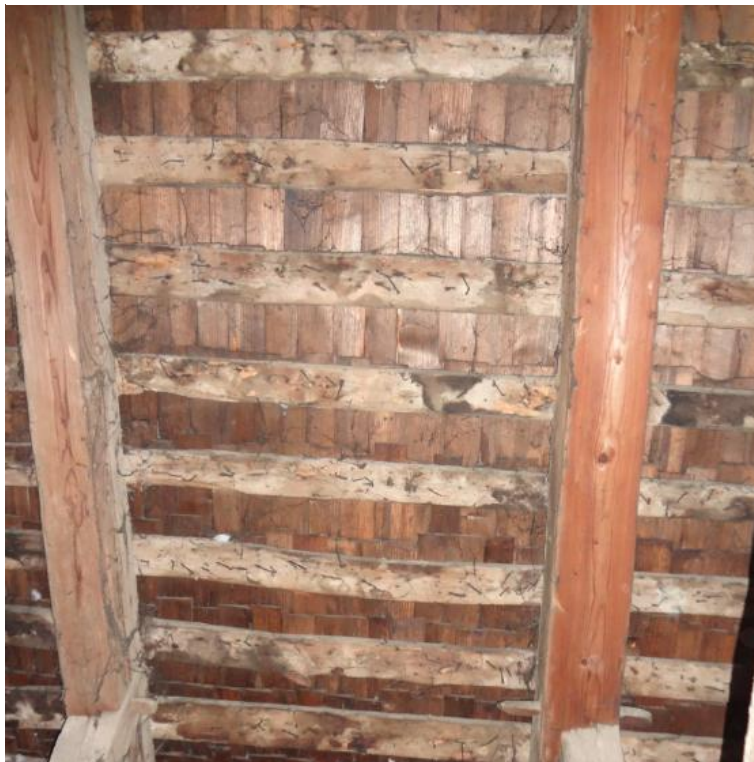
Fig. 4.14 – Laths nailed to rafters

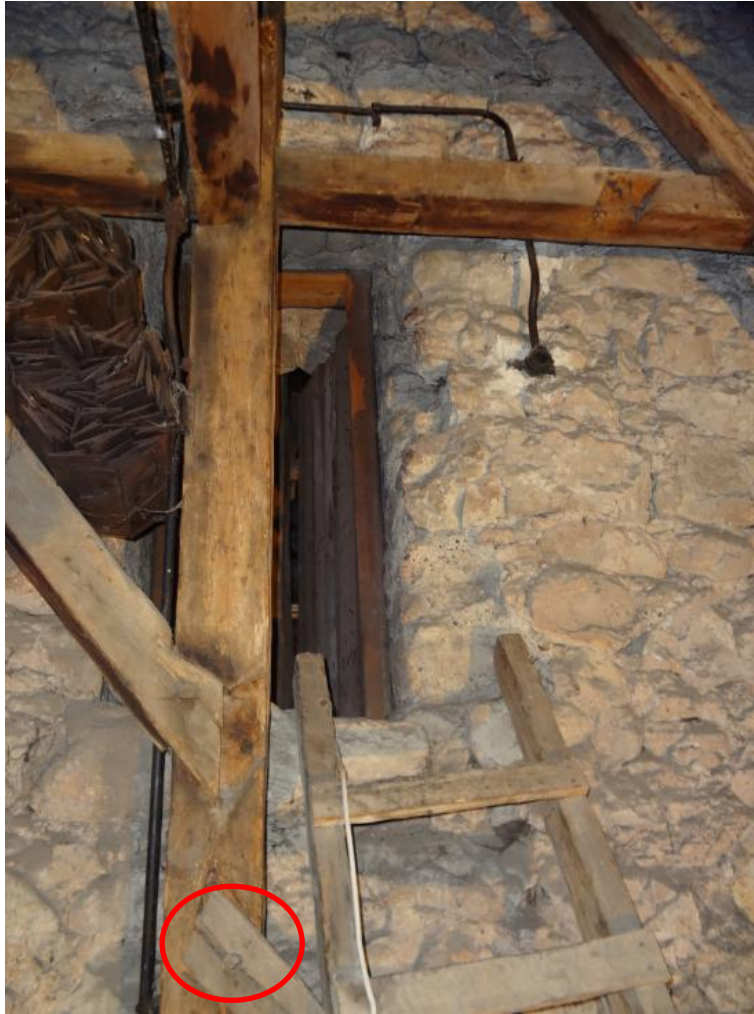
Fig. 4.15 – Missing upper knee brace and deteriorated angle brace connection.

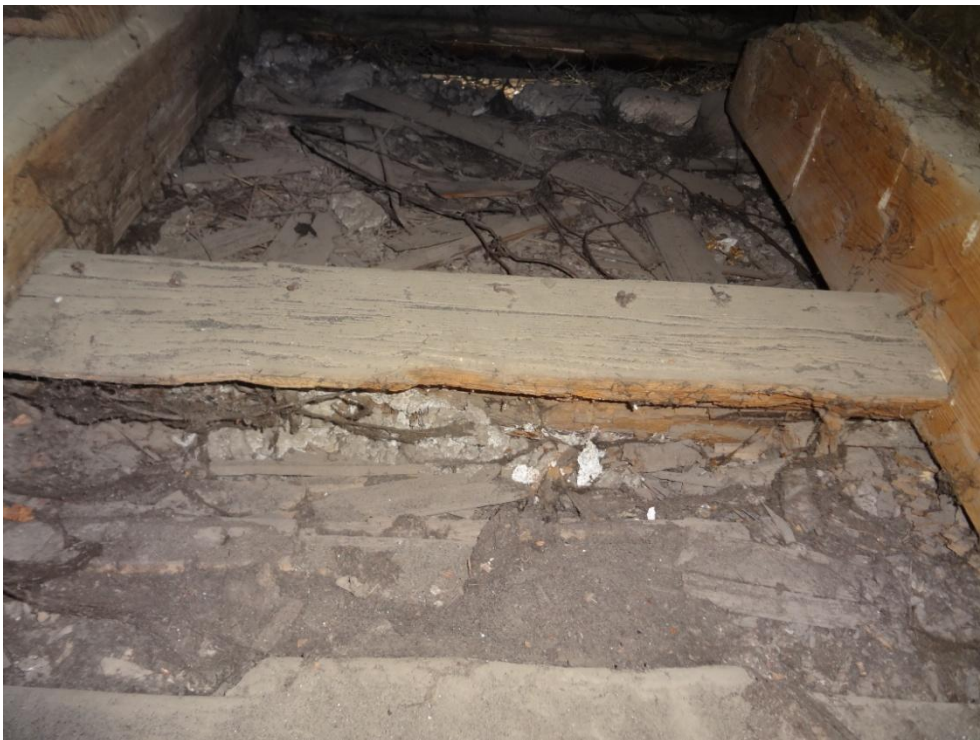
Fig. 4.16 – Deteriorated wall plate.

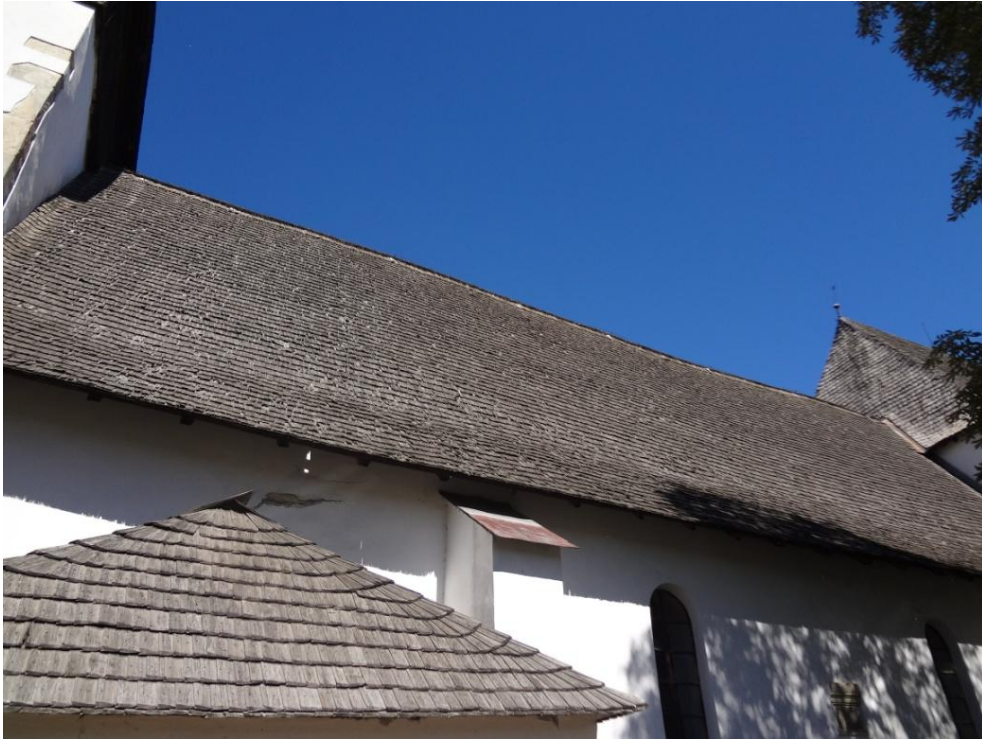
Fig. 4.17 – Shingles in bad condition.

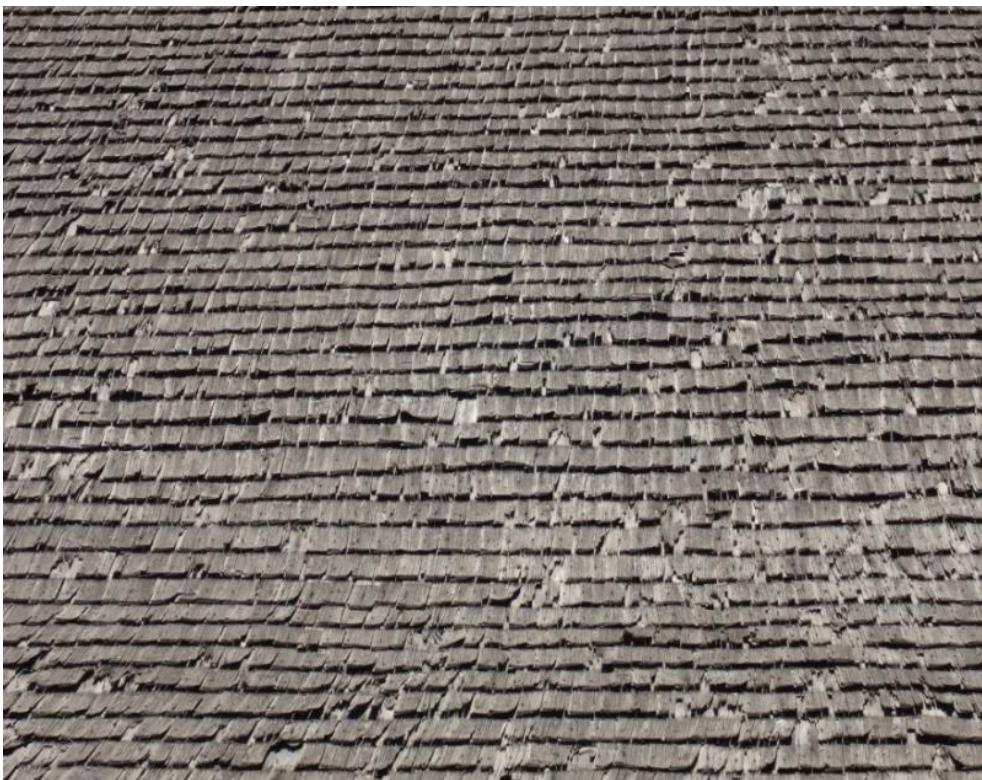
Fig. 4.18 – Shingles in bad condition – detail.

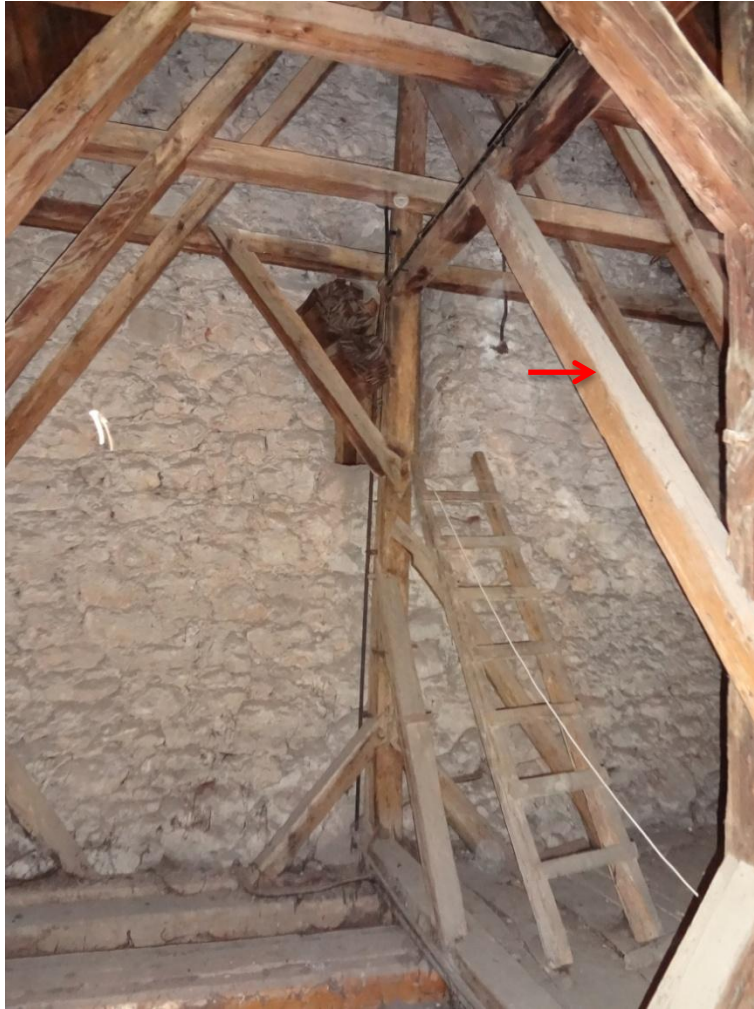
Fig. 4.19 – Replaced longitudinal passing brace.

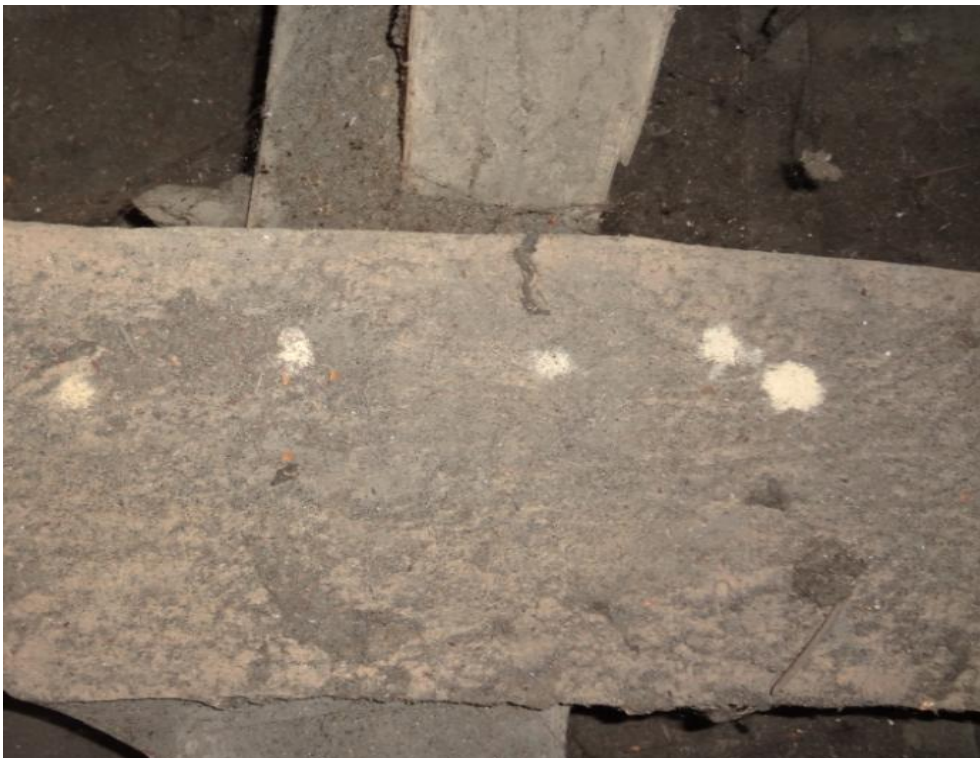
Fig. 4.20 – Wood dust from insect attack.

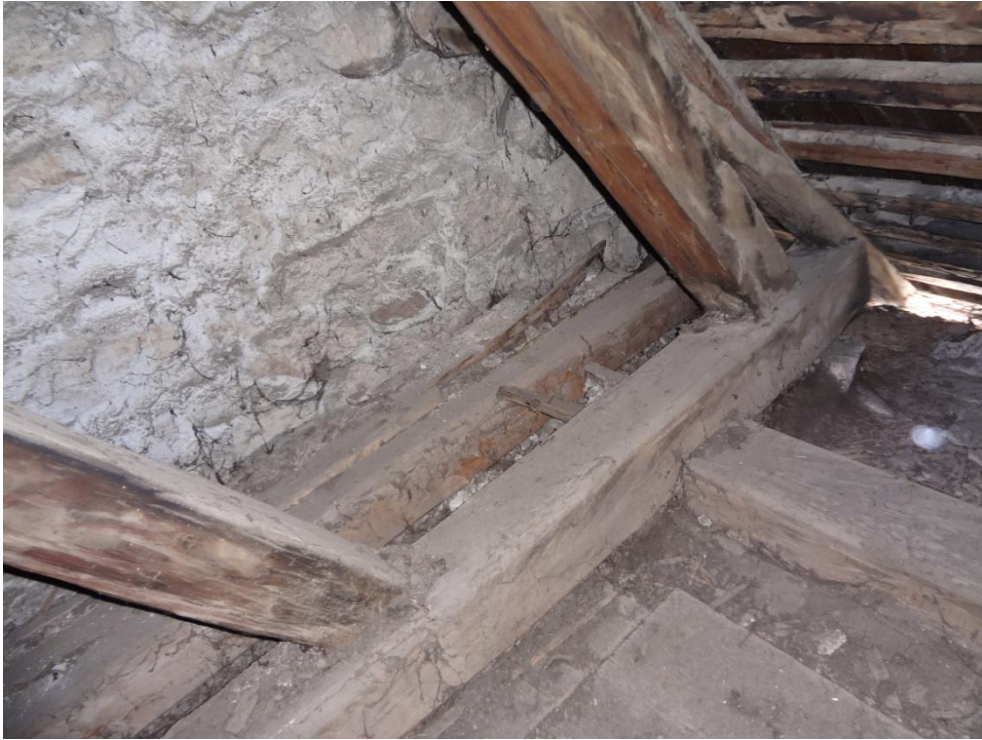
Fig. 4.21 - Both tie beams are deteriorated in the first truss, especially in the extremities.

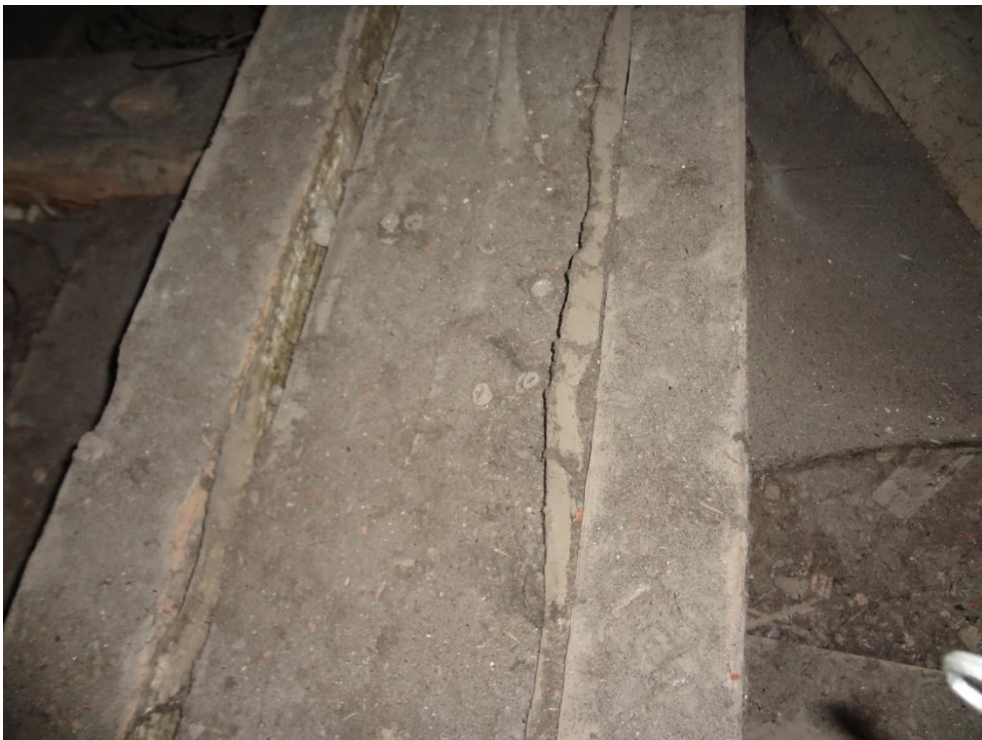
Fig. 4.22 – Tie beams entrapped by one additional timber element on each side.

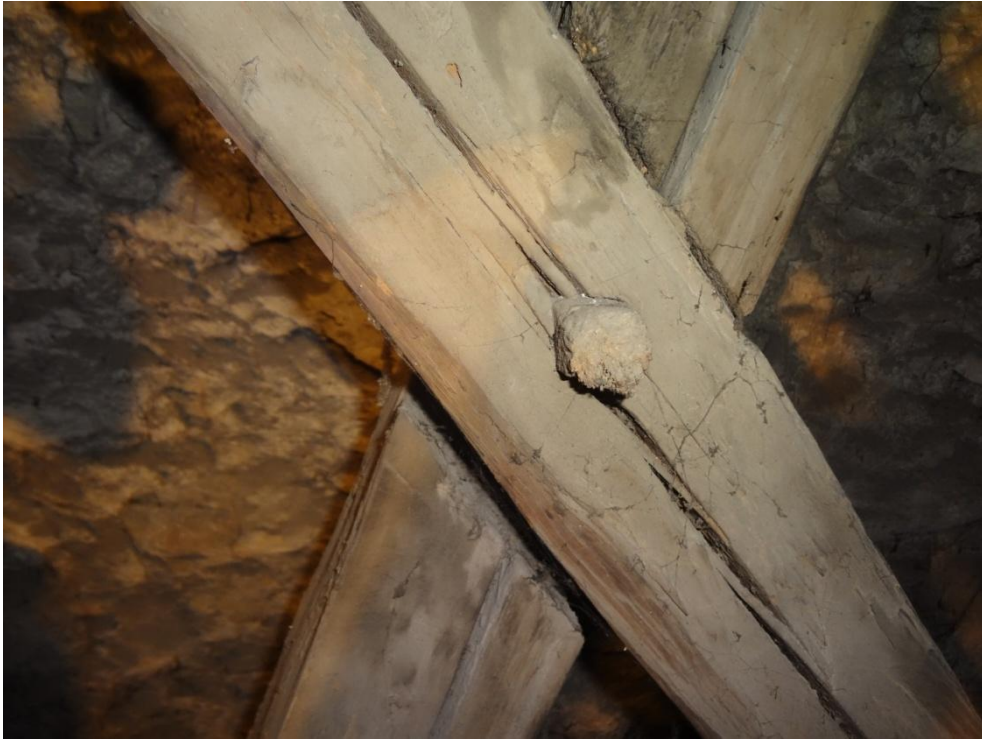
Fig. 4.23 – Longitudinal cracks in the structural elements.

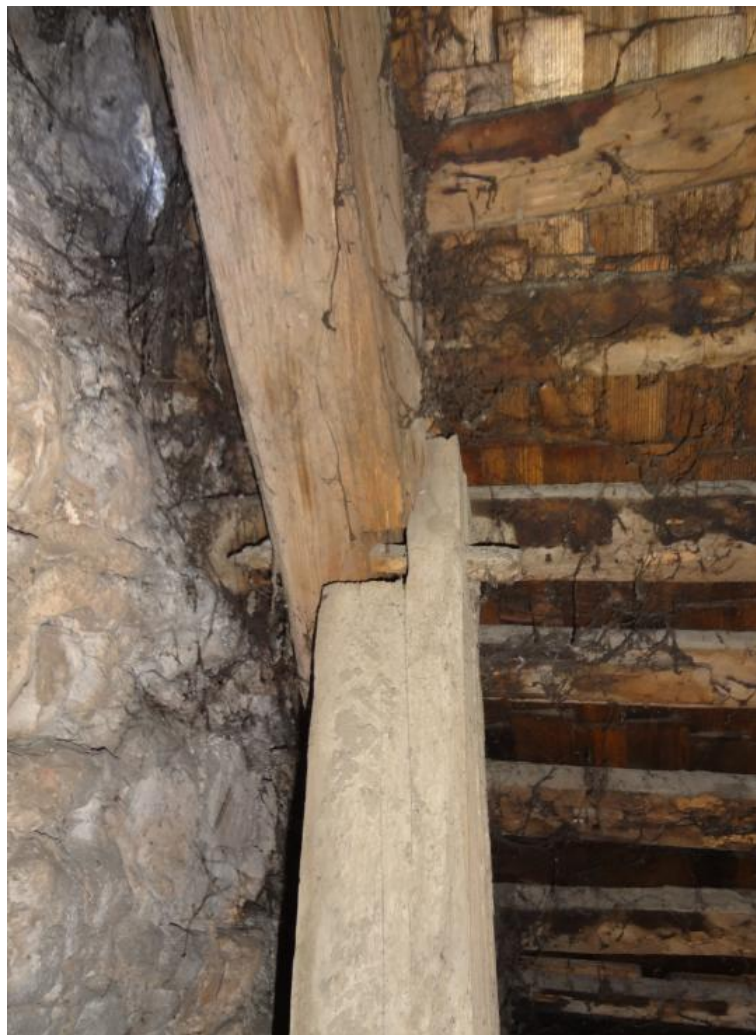
Fig. 4.24 – Gap between rafter and angle brace.

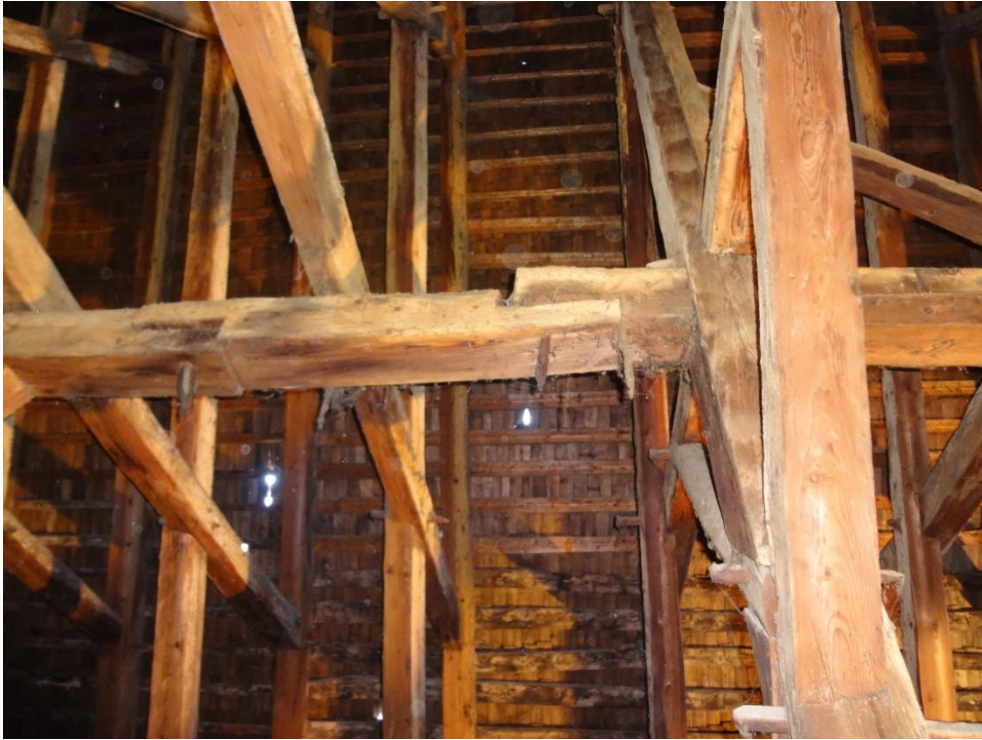
Fig. 4.25 – Gap in upper plate extension joint.

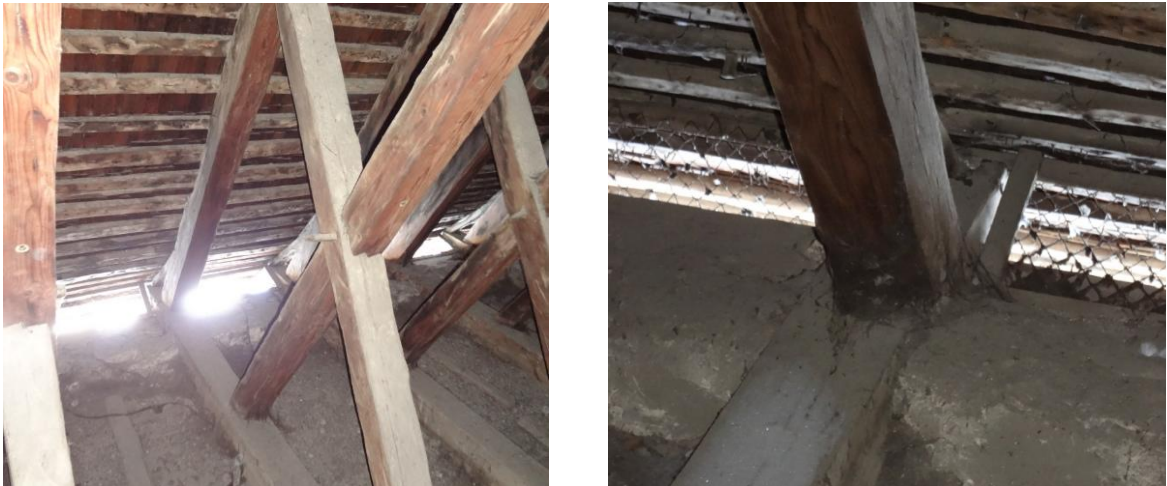
Fig. 4.32 – Roof openings

In both south and north part of the protruding roof there are equal openings as illustrated in Fig. 4.32.

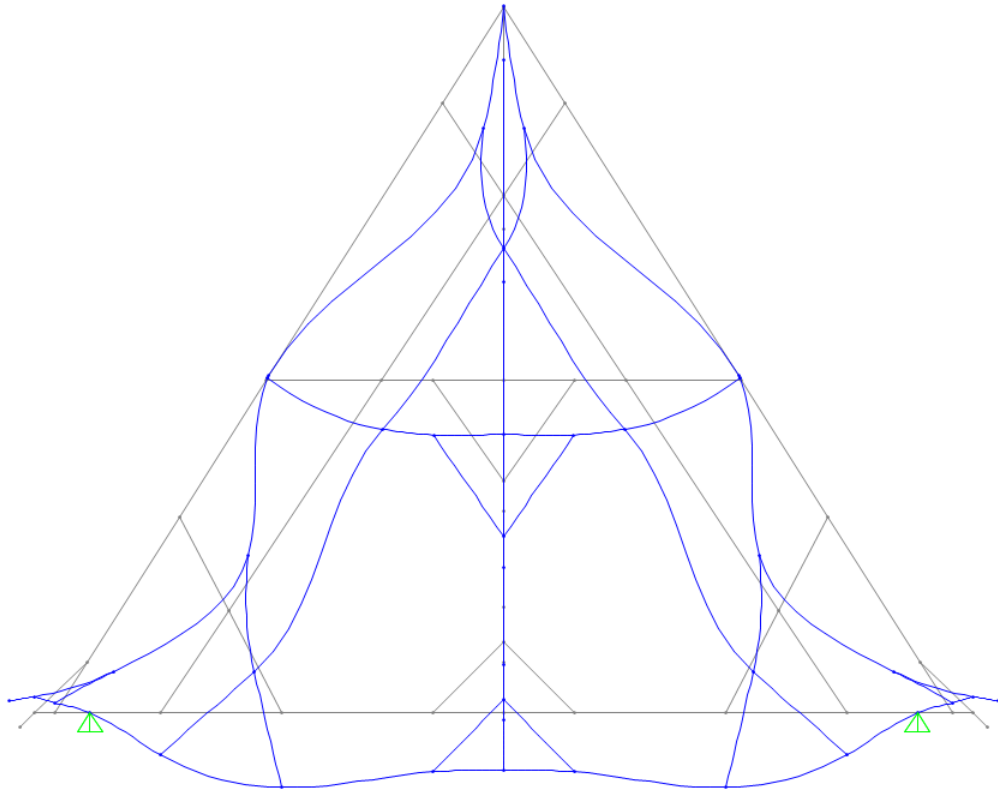
Fig. A.6 - Deformation [m] – king post not connected to rafters.
