Vernacular earthen buildings from Leiria, Portugal – Architectural survey towards their conservation and retrofitting

João Luís Parracha^{a,b}, José Lima^c, Maria Teresa Freire^{b,d}, Micael Ferreira^a, Paulina Faria^{a,b*}

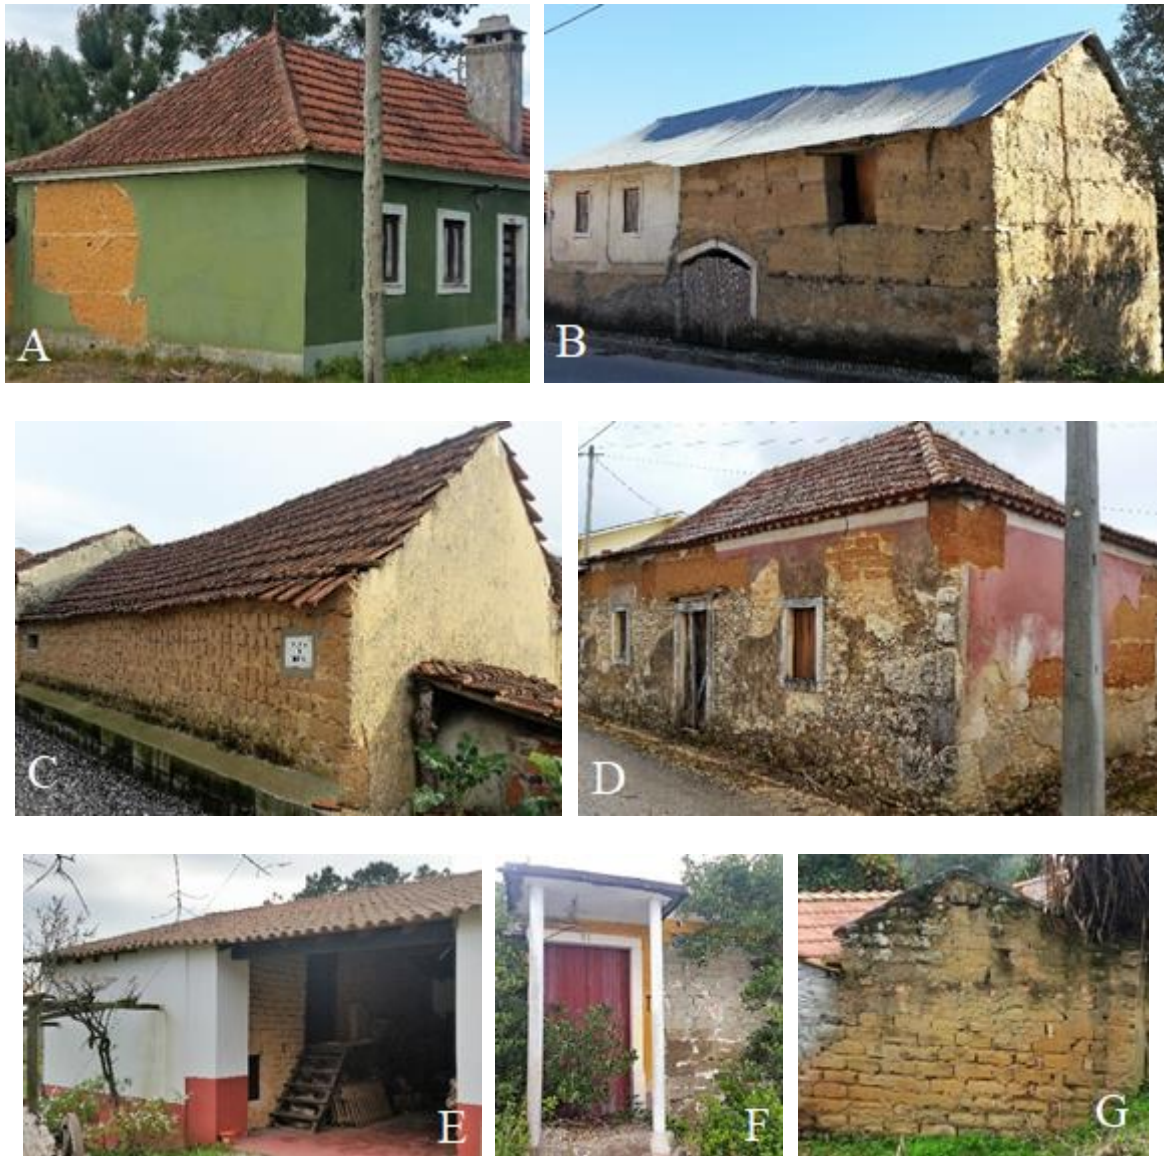
Figure 3. Some of the 98 mapped and inspected vernacular earthen buildings: A – rammed earth building 77 from Pombal; B – rammed earth building 10 from Pombal; C – adobe building 65 from Leiria; D – mixed construction 38 from Pombal; E – adobe building 93 from Leiria; F – adobe building 87 from Leiria and G – adobe building 42 from Leiria

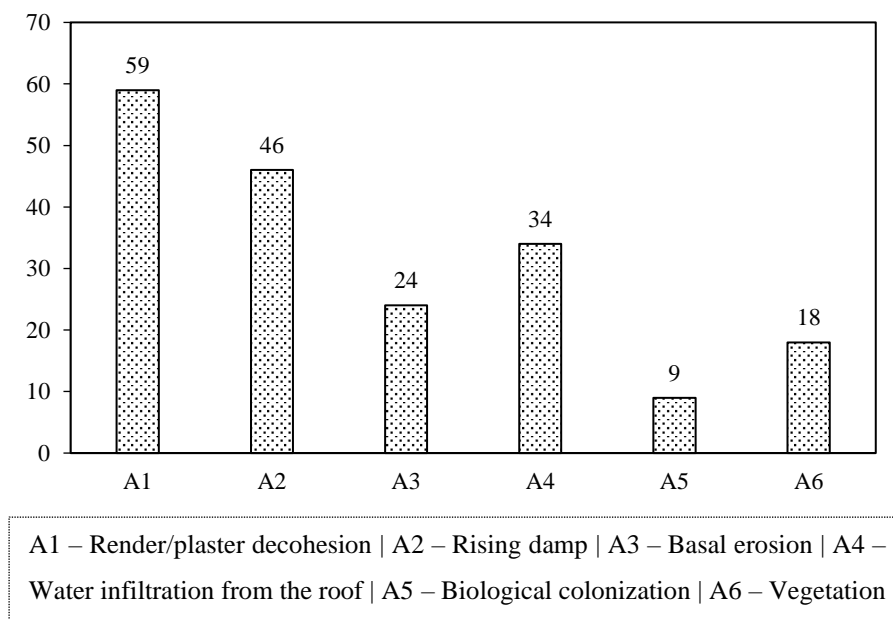
Figure 6. Absolute frequency of the anomalies identified in the survey

As shown in Figure 6, the most frequent anomalies are A1 (render/plaster decohesion), A2 (rising damp) and A4 (water infiltration from the roof), illustrated in Figures 7 and 8 and Table B.3 of Appendix B. The latter strongly increases in cases of abandoned dwellings.

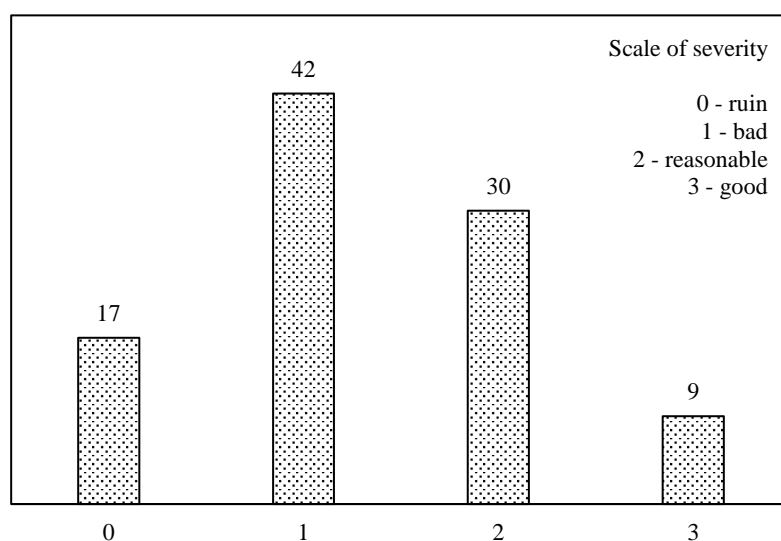
Figure 9. General condition of the inspected buildings

Table B.3 of Appendix B lists the severity levels assigned to each of the 98 inspected buildings. As shown in Figure 9, it is possible to observe that 17% of the inspected buildings are in a state of ruin, 43% are in a bad condition, 31% are in a reasonable one, and only 9% of the 98 inspected buildings present a good condition. The fact that most of the inspected buildings (60%) are in a poor condition, considered ruin or bad, is justified by the lack of maintenance or incorrect interventions over time and reinforces the importance of study this type of built heritage towards their conservation and retrofitting.

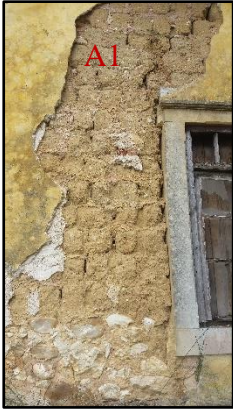
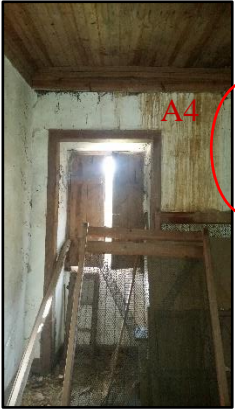
Building reference	General condition (scale from 0 – ruin to 3 – good*)	Building pathology**	Detail (when relevant)
1	0	-	See Table B.2
2	3	A1	-
3	2	A1; A4; A6	-
4	1	A1; A4; A5	<div style="display: flex; justify-content: space-around;">

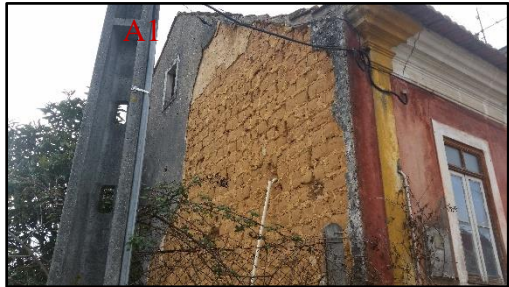
Building reference	General condition (scale from 0 – ruin to 3 – good*)	Building pathology**	Detail (when relevant)
6	2	A1; A2

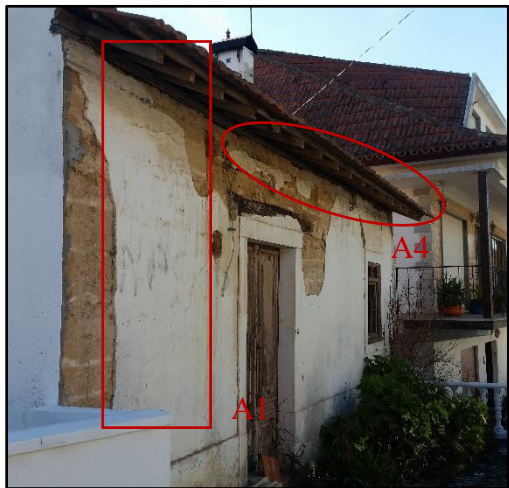
7	2	A1; A2	-
8	3	-	-
9	1	A1; A2; A3	-
10	1	A1; A2; A3; A4; A6	-
11	2	A1; A4

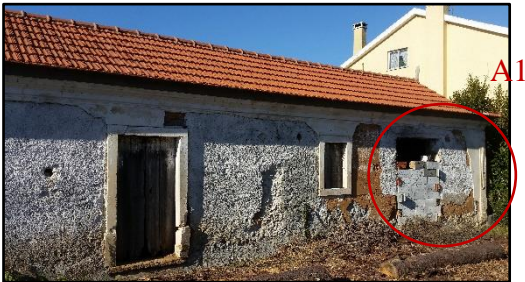
Building reference	General condition (scale from 0 – ruin to 3 – good*)	Building pathology**	Detail (when relevant)
17	2	A1; A2

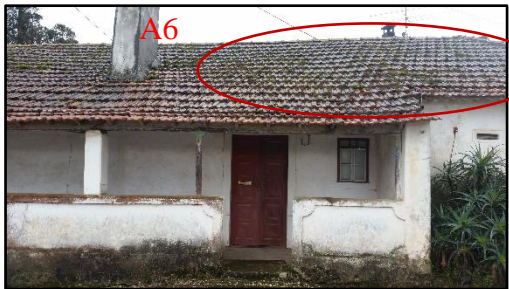
Building reference	General condition (scale from 0 – ruin to 3 – good*)	Building pathology**	Detail (when relevant)
30	1	A2; A4	-
31	1	A1; A2; A4	-
32	2	A1	-
33	2	A1	-
34	3	-	-
35	2	A1; A2	-
36	2	A1; A2	-
37	1	A1; A2; A4; A6

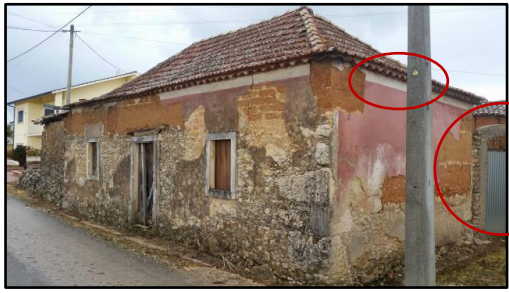
38	1	A1; A2; A4; A5

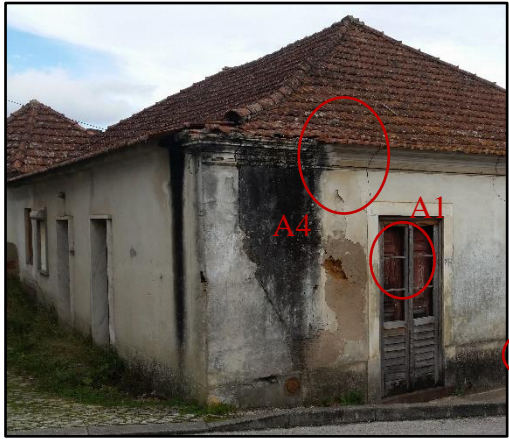
39	1	A2; A3	-
40	1	A1; A2; A3	-
41	1	A1; A2; A4; A6

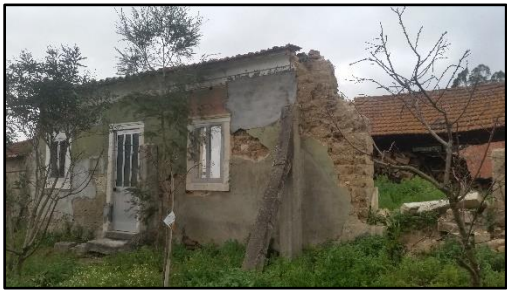
57	1	A1; A2; A4

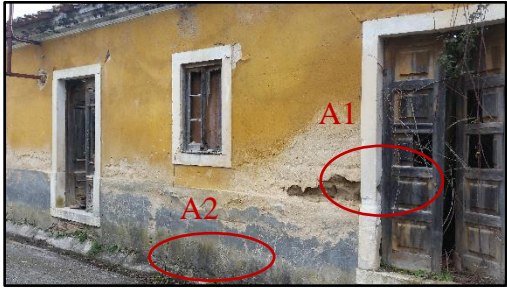
58	0	-	-
59	2	A1	-
<p>*Scale of severity: 0 – ruin; 1 – bad; 2 – reasonable; 3 – good. **If the scale of severity points to 0 (ruin), the building pathology is not mentioned; Anomalies identified in the survey, according to Section 3.2: A1 – Render/plaster decohesion; A2 – Rising damp; A3 – Basal erosion; A4 – Water infiltration from the roof; A5 – Biological colonization; A6 – Vegetation growth.</p>			
Building reference	General condition (scale from 0 – ruin to 3 – good*)	Building pathology**	Detail (when relevant)
60	1	A1; A2; A4; A6

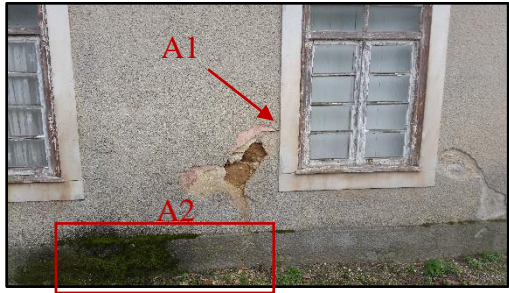
68	2	A1; A2	-
69	1	A1; A2; A4; A5; A6	-
70	2	A1; A4	-
71	1	A1; A2; A3	-
72	0	-	-
73	1	A1; A2; A3; A4	-
<p>*Scale of severity: 0 – ruin; 1 – bad; 2 – reasonable; 3 – good. **If the scale of severity points to 0 (ruin), the building pathology is not mentioned; Anomalies identified in the survey, according to Section 3.2: A1 – Render/plaster decohesion; A2 – Rising damp; A3 – Basal erosion; A4 – Water infiltration from the roof; A5 – Biological colonization; A6 – Vegetation growth.</p>
