# The compatibility of earth-based repair mortars with rammed earth substrates

## Abstract

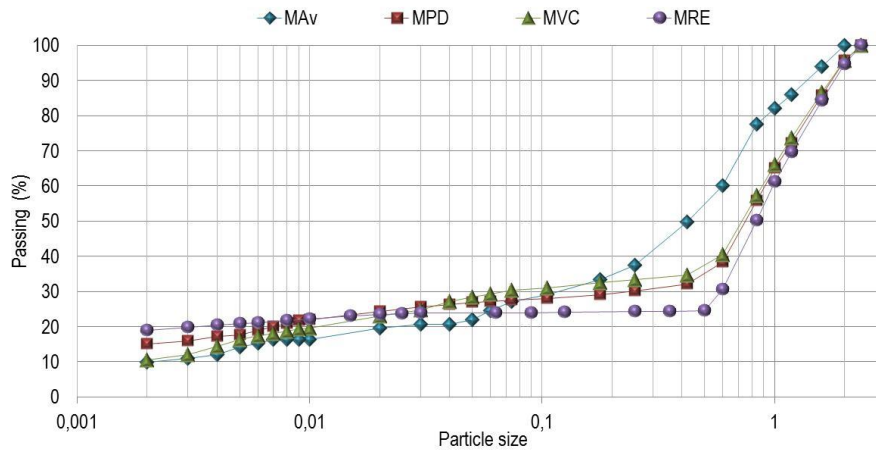
Figure 1: Particle size distribution of the mortar materials, MAv, MPD, MVC and MRE

Figure 1 shows the particle-size distribution of the unstabilized materials for the mortars, MAV, MPD, MVC and MRE.

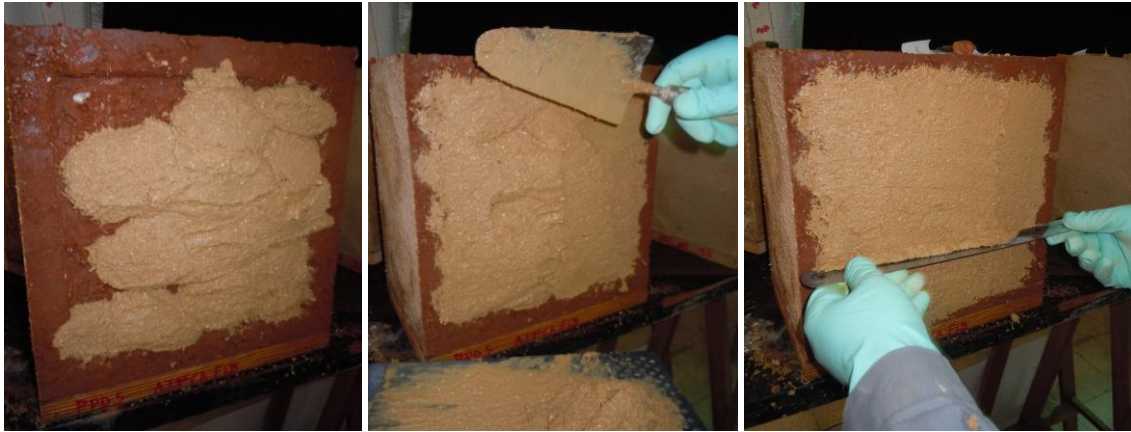
Figure 2: Application of the mortar MRE\_AL15 on a standard superficial defect of the PD rammed earth

The application technique of the repair mortars in the superficial was the following (Figure 2):

- (i) the mortar was thrown vigorously against the support with a trowel, always from the bottom to the top;
- (ii) the mortar was tightened and repointing was made particularly at the corners, with a trowel;
- (iii) the surface of the mortar was regularized with a wooden or metal ruler;
- (iv) the surface of the mortar was smoothed with a sponge.

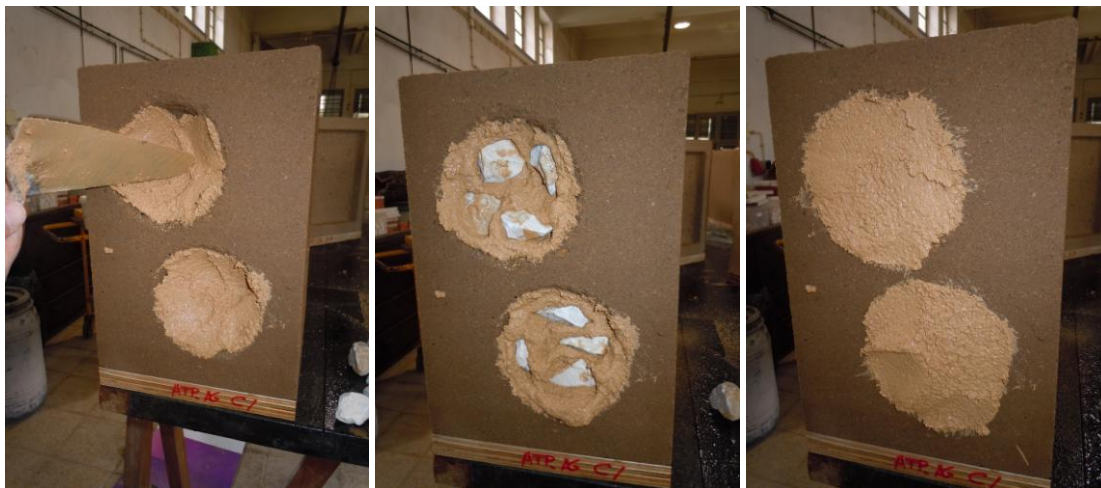
Figure 3: Application of the mortar MRE on a standard deep voids defect of the Av rammed earth

In the case of the deep defects the mortar was applied by the following procedure (Figure 3):

- (i) the mortar was launched vigorously against the support with a trowel followed by tightening; the thickness of this first mortar layer was of 0.5 to 1 cm;
- (ii) in the case of using coarse gravel to partially fill the holes of the defects these were applied after this first layer of mortar;
- (iii) the interval of 15-20 min between the application of mortars layers was respected so that the previous layer had time to achieve enough resistance;
- (iv) the application of the last layer of mortar was careful, especially in the zone of connection with the support and the repointing should be carried out, if necessary;
- (v) the surface was regularized with a wooden or metal ruler;
- (vi) finally the surface was smoothed with a sponge.

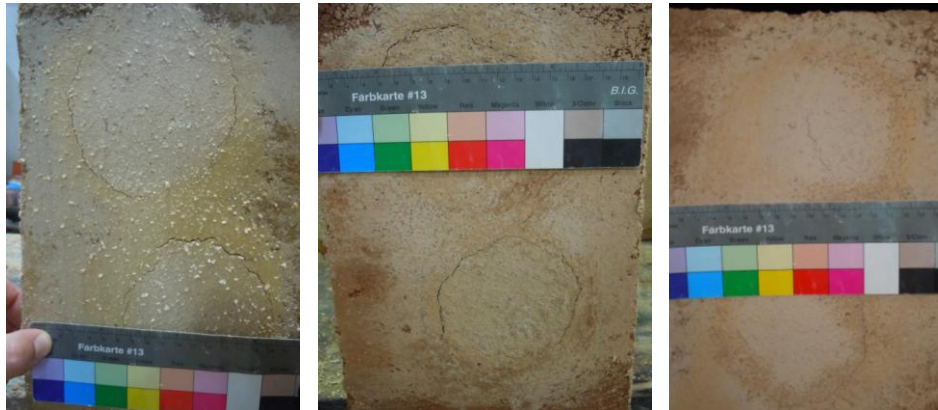
Figure 4: Medium cracks on the mortar MRE\_AL15 applied on the standard deep voids defect in the blocks: left, in BAV; center, in BPD; and right, in BVC

- (i) the unstabilized mortars MAv, MPD and MVC applied on blocks of the same type of earth showed the best performance, presenting just contour cracks;
- (ii) the performance of the stabilized MRE-based mortars (Figure 4) was always worse than that of the unstabilized MRE mortars: cracking was more intense and sometimes was accompanied by detachment of the repair mortar;
- (iii) loss of adhesion between the mortar and the support was verified only for the Av substrate which has low clay content;

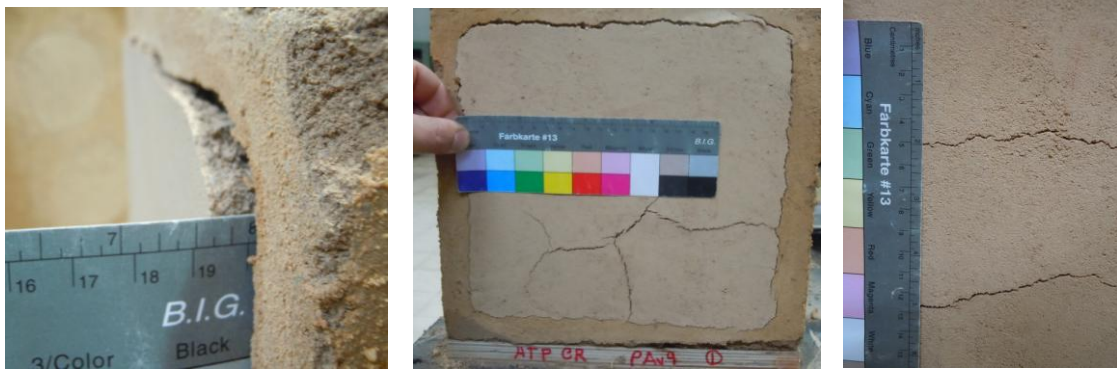
Figure 5: Mortar MRE\_NC15 applied in block BA<sub>v</sub> on standard superficial defect: left, detachment of the mortar; center, cracks; and right, detail of large cracks

The stabilized mortars behaved worse, particularly in the case of the BAV substrate where detachment of the whole repair occurred in several cases (Figure 5). This was probably due to the lower adesion provided by this relatively high sand content substrate.
